Appendix E

Long Sea Outfall Photographs -
January 2017

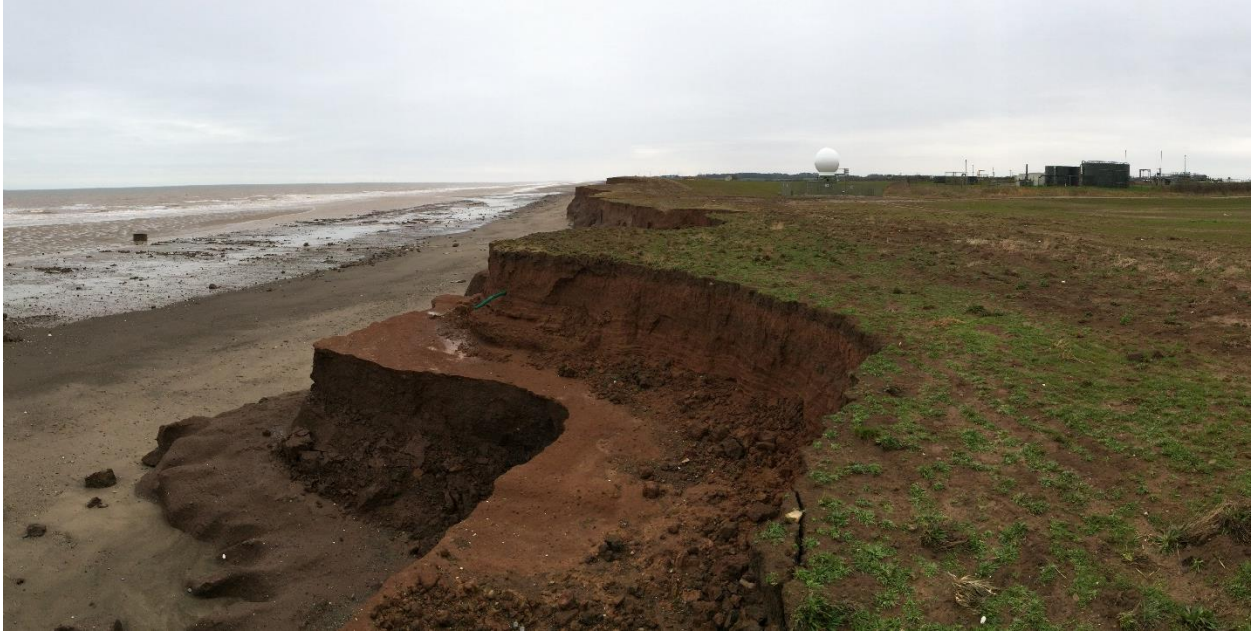
Figure 2017: 1 General view of outfall and WwTW (note construction shaft on the beach)

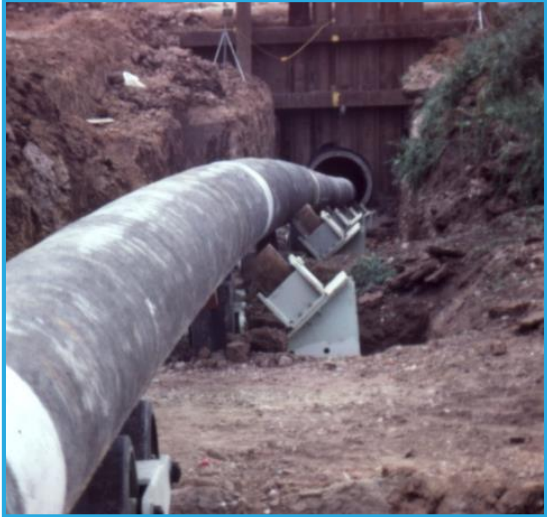
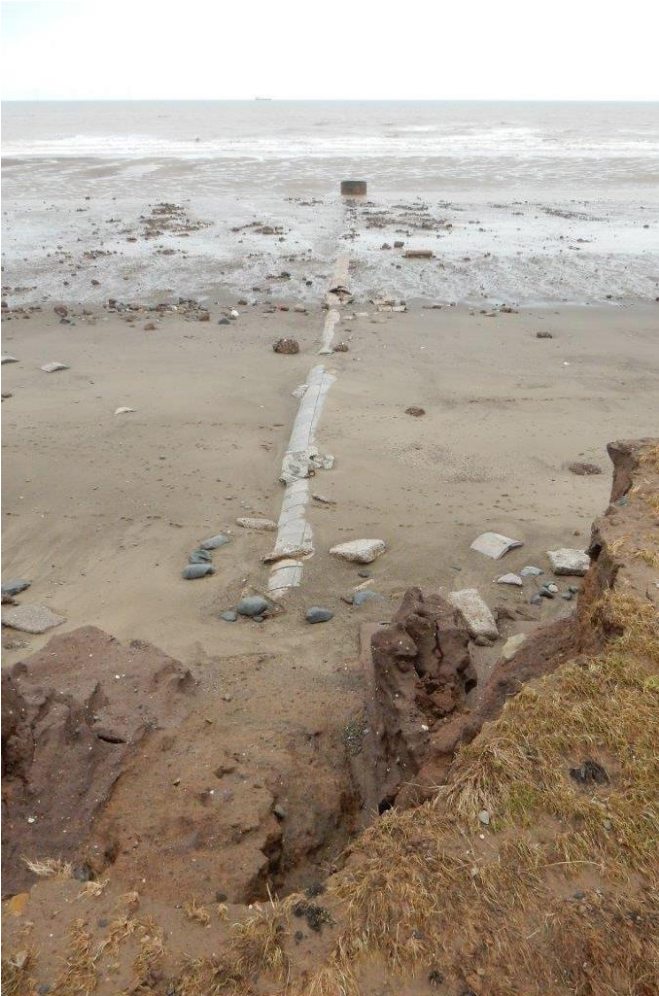
Figure 2017: 02

Long Sea Outfall viewed from the cliff top. Note that the more orange clay in the foreground appears to be trench backfill. The start of the tunnelled section must be beyond this. Figure 4 in the main report (inset below) must have been taken at a similar location to this but at a lower level.

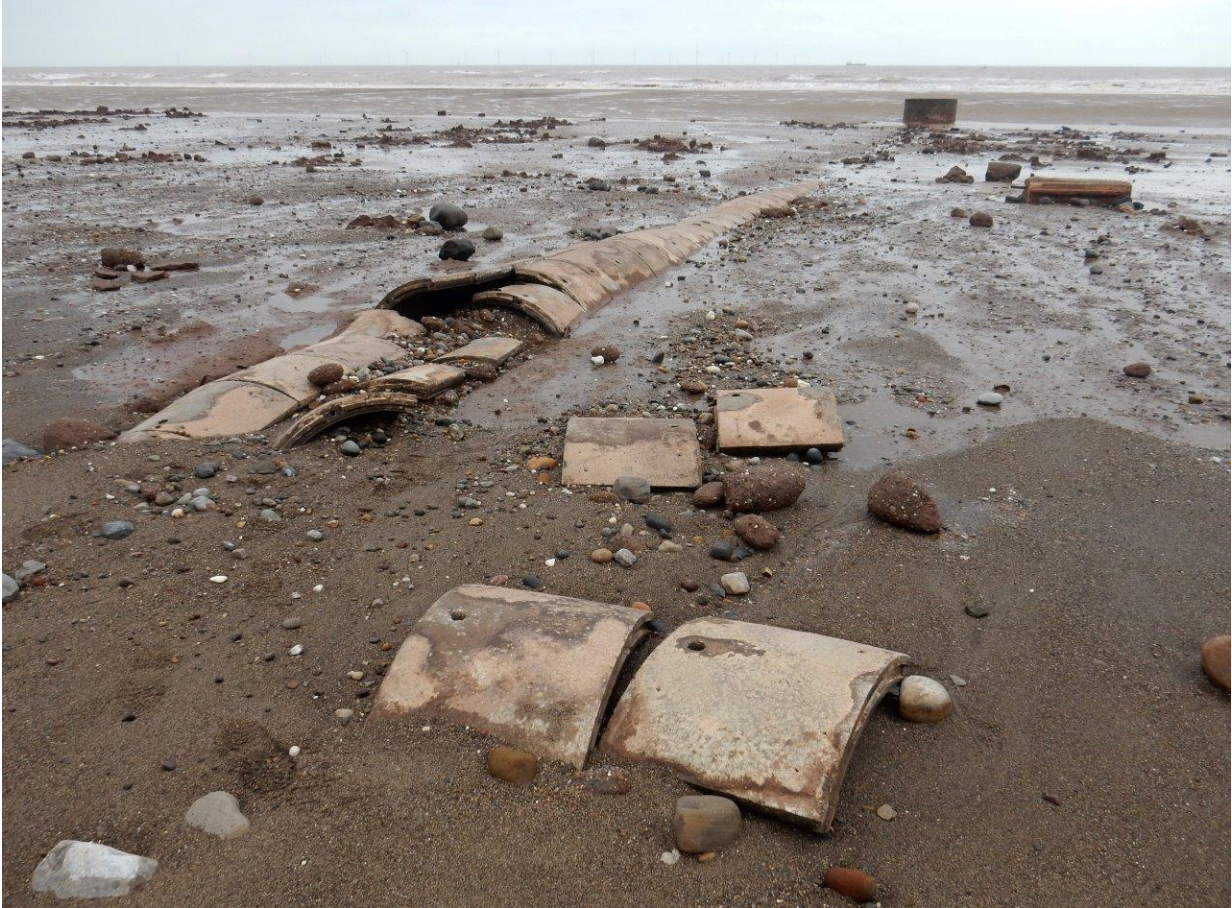
Figure 2017: 03 Outfall construction tunnel damaged by wave action

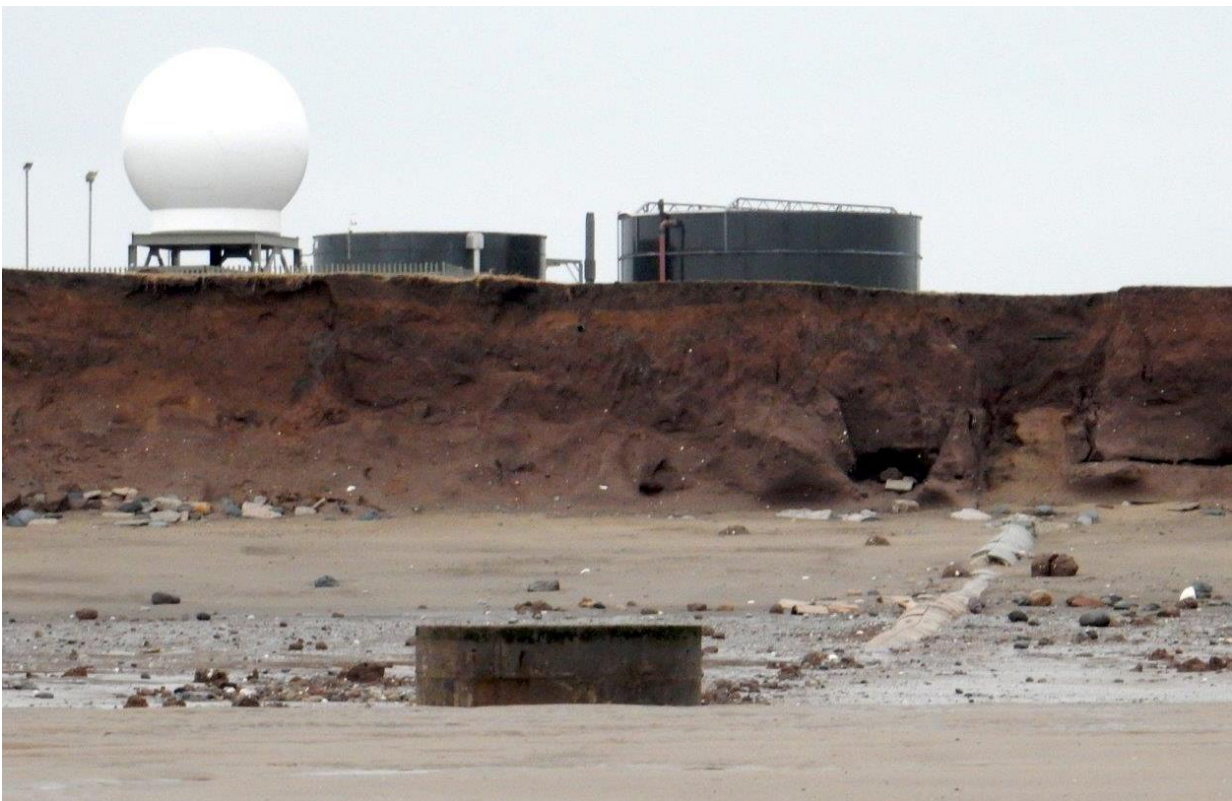
Figure 2017: 04 Construction shaft on the beach with exposed tunnel section and WwTW
