Aldbrough Gas Storage Project: Geomorphological assessment of impact of proposed cliff protection works on adjoining areas

External Investigation Report No. EX1214

October 2010

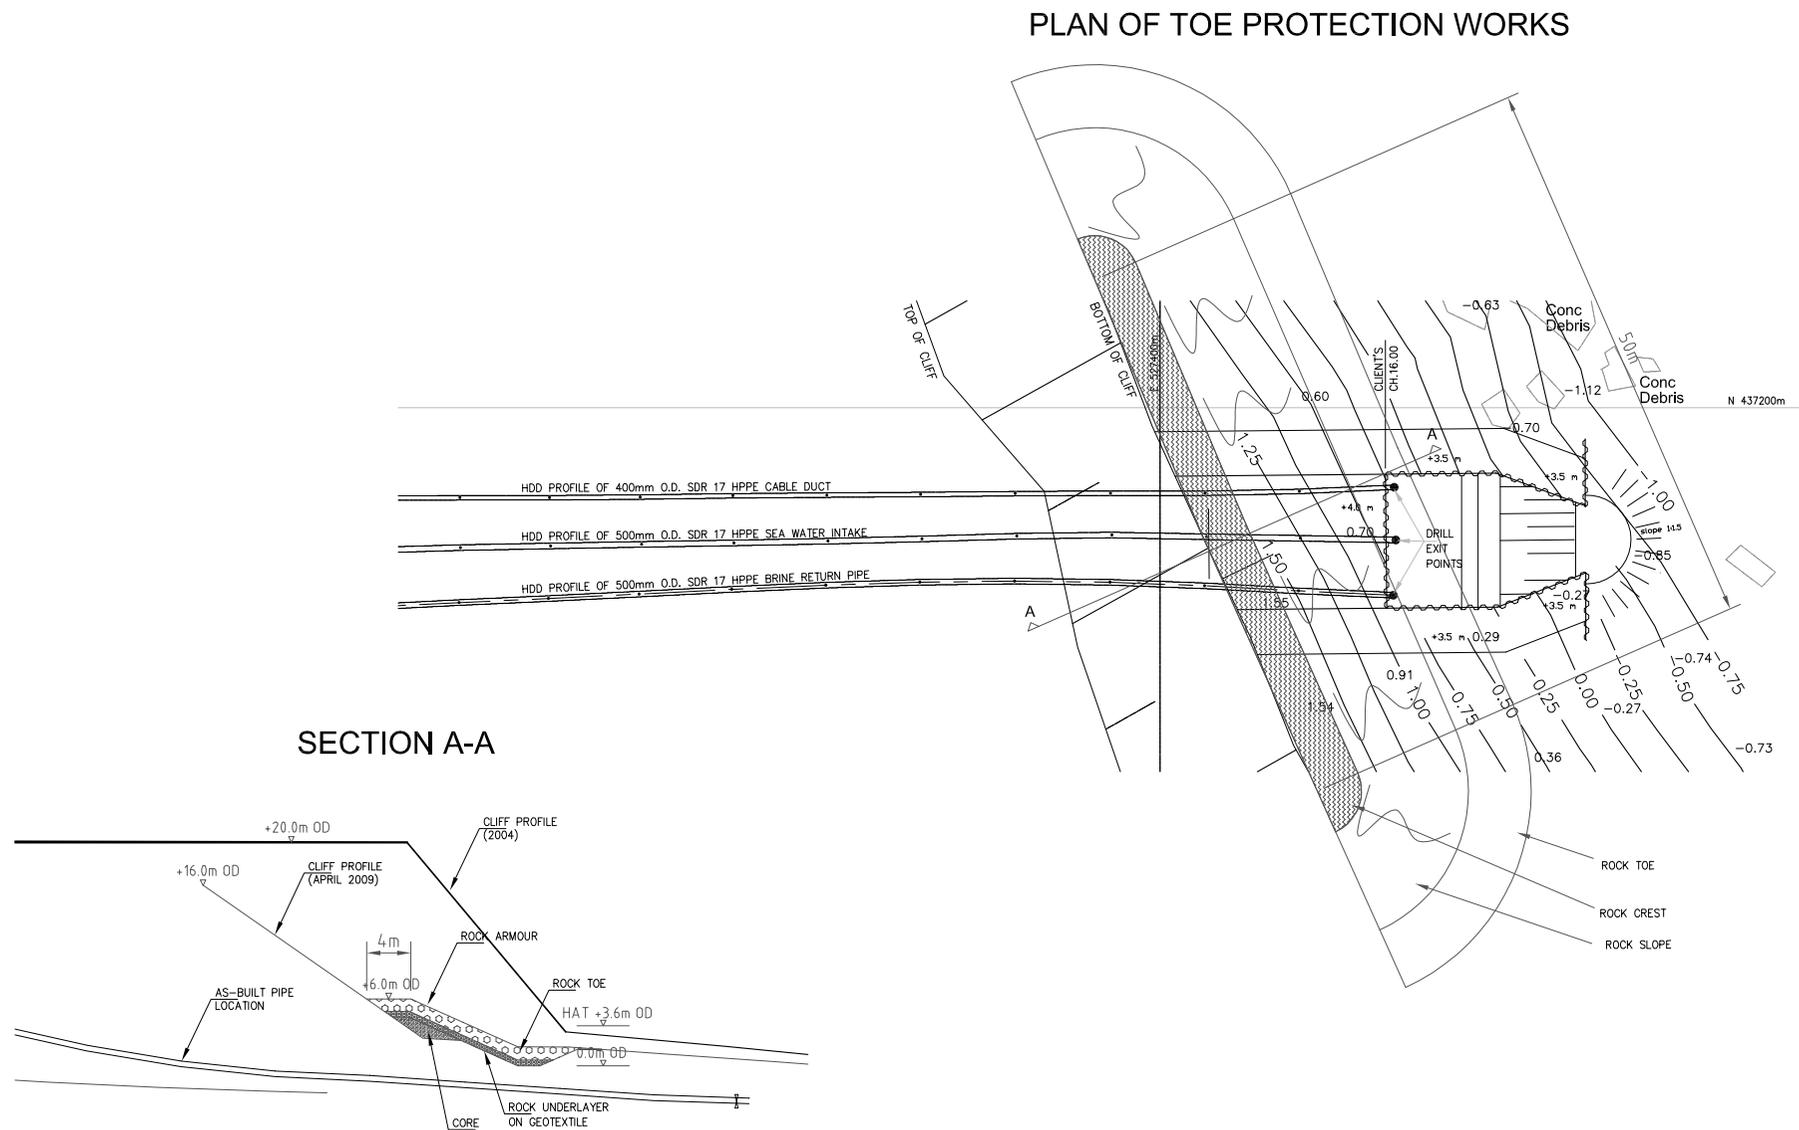
Figure 2 Diagram of the proposed works to protect the cliff toe and underground pipe from the Gas Storage Facility from coastal erosion. Source: Boyes *et al.* (2010).

Jacobs and SSE have concluded that the preferred option is to adopt a maintenance approach and have developed proposals to protect the cliff toe around the pipelines for a projected period of two years. The initial proposals, put forward in May 2010, involved the use of rock armour to protect the cliff toe (Figure 2). The environmental impact of the proposed works was assessed by IECS (Boyes *et al.* 2010). Their report concluded that the scheme might result in a 'sediment transport loss' of 1000 m³ and a 'sediment supply loss' of 10,000 m³ over the two-year period. This compared with an estimated sediment volume of 400,000 to 700,000 m³ moving down the coast over that period (i.e. the proposed development might lead to a reduction in down-drift sediment volume of 1.5 to 2.75%). It was suggested that the sediment supply disruption from the project could be offset by placing sacrificial material on the shore.

Since the original submission, revised design proposals have been developed which involve the use of *Secutex Soft Rock*[®] geotextile containers rather than rock armour in the cliff toe protection. Potential sources of material to fill the containers include glacial sediment excavated from the upper part of the cliffs, the beach in the vicinity of the proposed works, and imported material. The potential suitability of using sediment from the cliffs or the beach for use in the Soft Rock containers is also considered in this report.

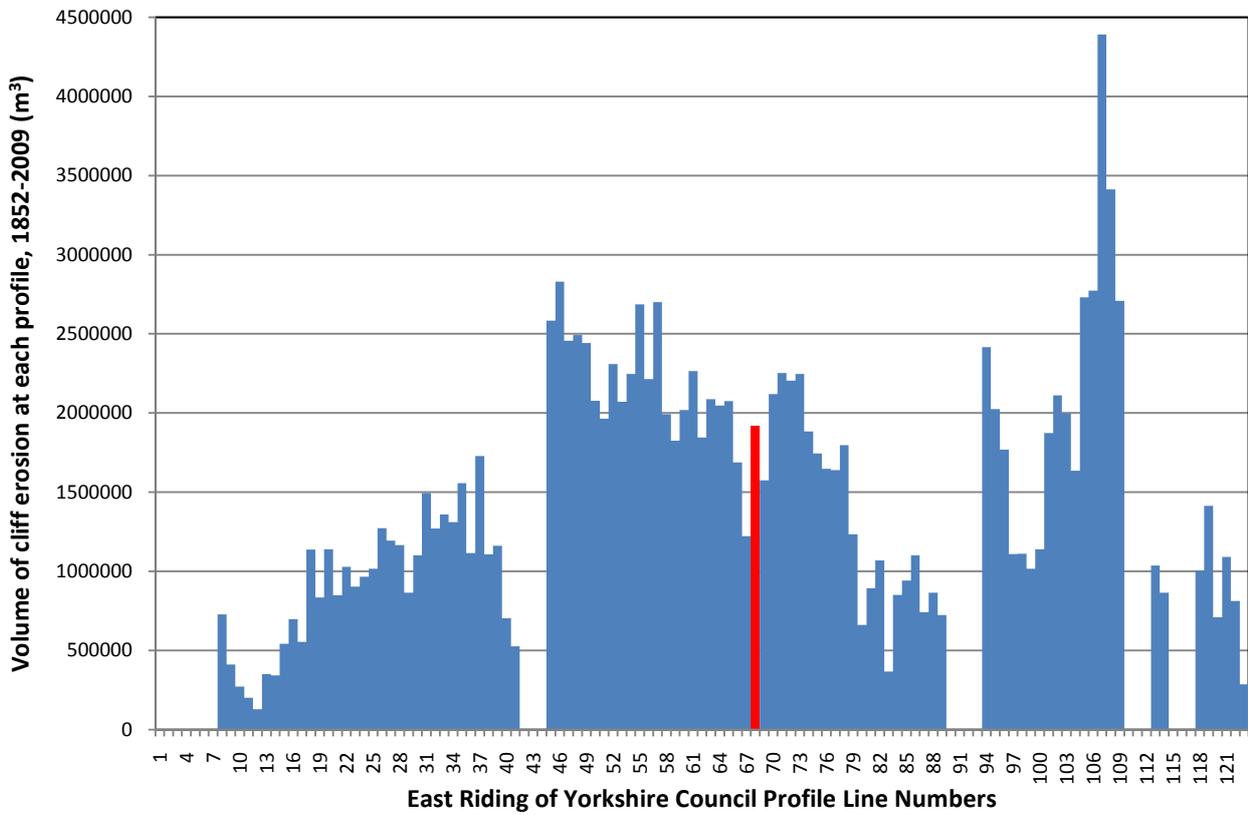
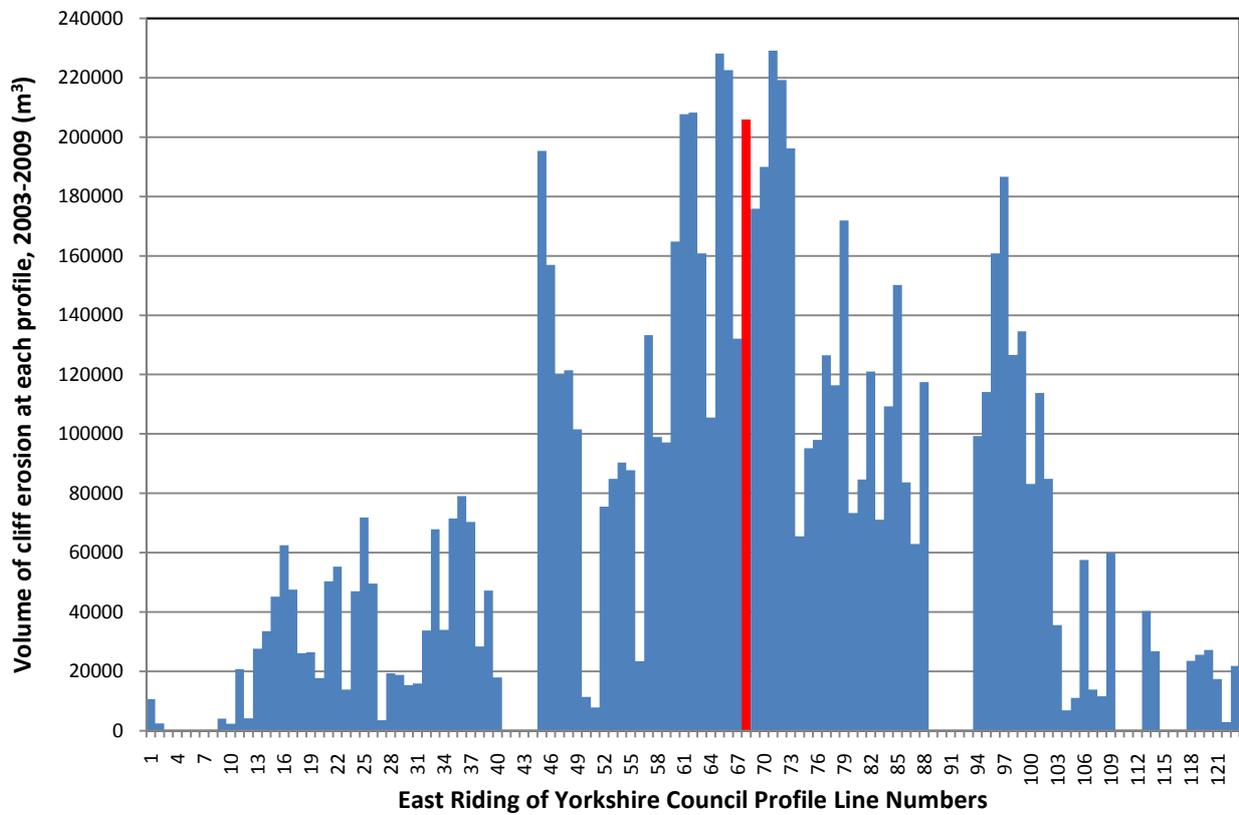
Figure 3 Volumes of sediment eroded from the cliffs along the Holderness coastline between: (a) 1852 and 2009; and (b) 2003 and 2009. Volumes are calculated for 500 metre lengths of coastline, centred on each East Riding of Yorkshire Council profile line. Volumes for Profile 68 (the 500 metre section closest to the Aldbrough Gas Storage Facility) is highlighted in red. Note the different vertical scales.

The geographical variation in input of sediment from the Holderness cliffs between 1852 and 2009, and between 2003 and 2009, is shown in Figure 3. The volumes of material released from different sections of the coast in different time periods are summarised in Table 2.

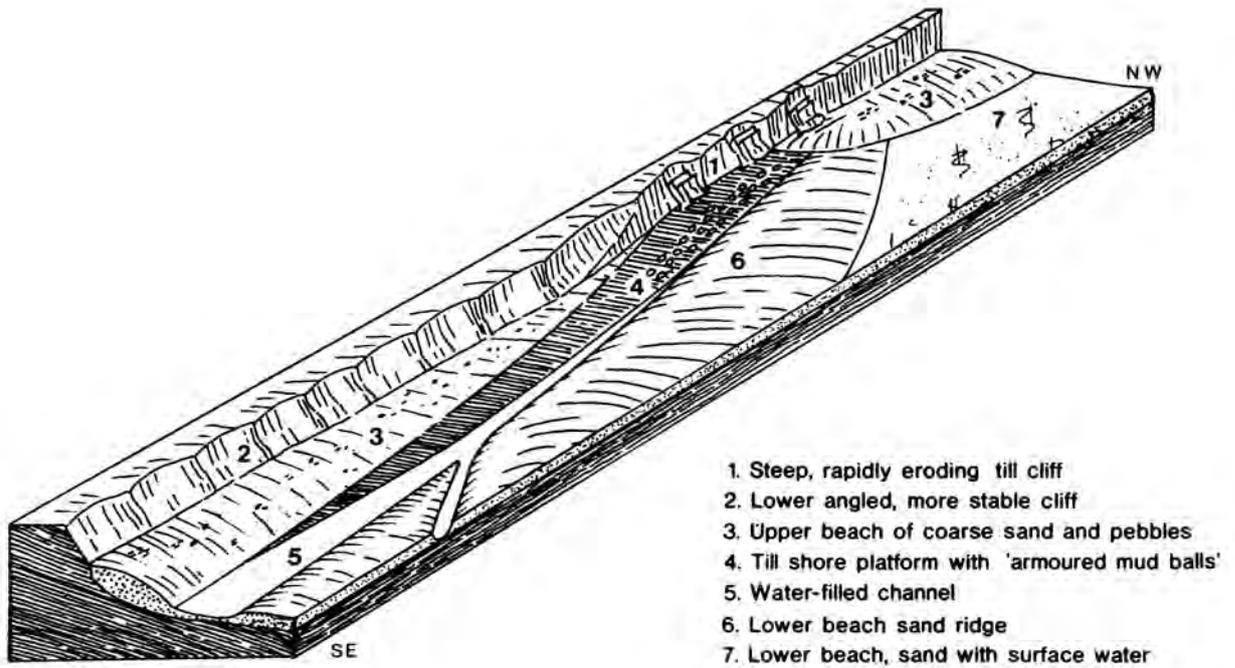
Figure 4 Schematic diagram of a Holderness ord. After Pringle (1985).

The ord approaches the cliff toe and becomes narrower and shallower in a northerly direction, pinching out altogether just south of Cliff Farm (Grange Farm Cottage shown on Figure 10). To the south of Ringbrough Farm the ord moves further offshore and there is a relatively wide till platform in front of the cliffs. The general association of upper beach slope, till platform, water-filled trough and mid beach sand ridge is similar to that described by Pringle (1985) and shown schematically in Figure 4.

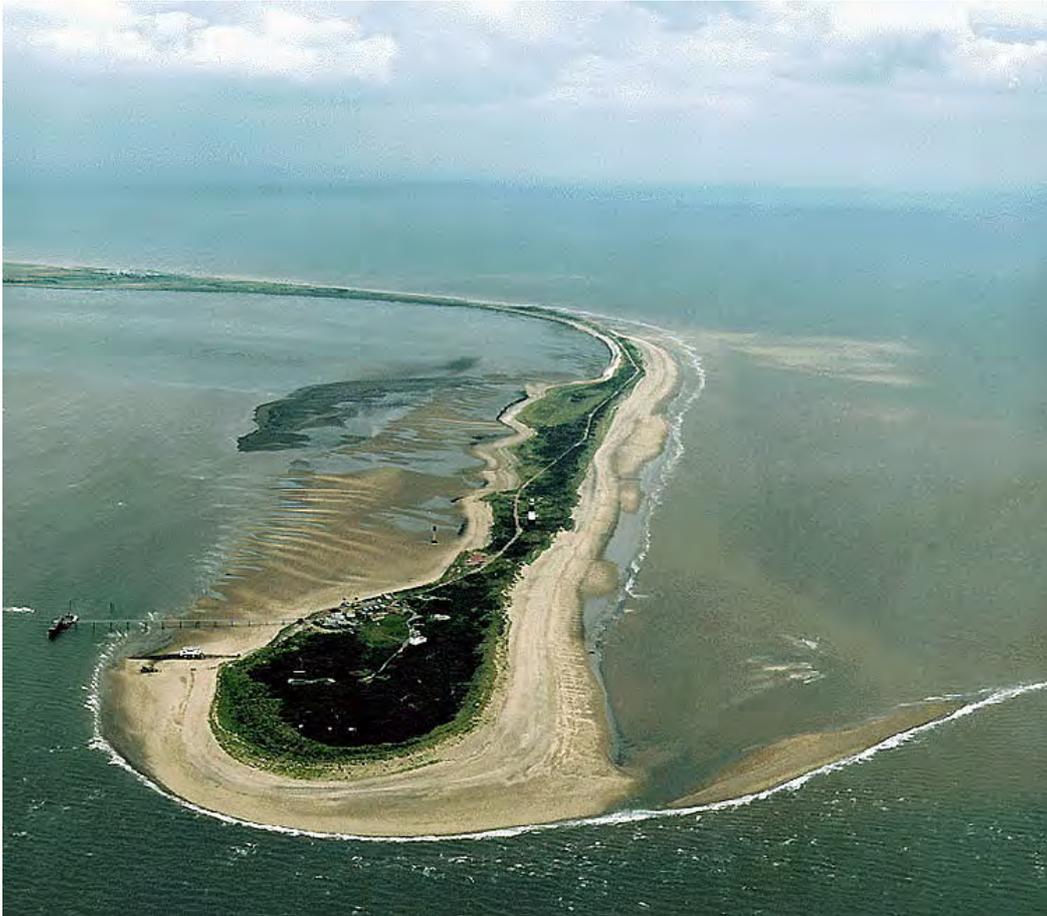
Figure 6 Aerial photograph of Spurn Head, taken in 1996. Source: tife.org.uk.

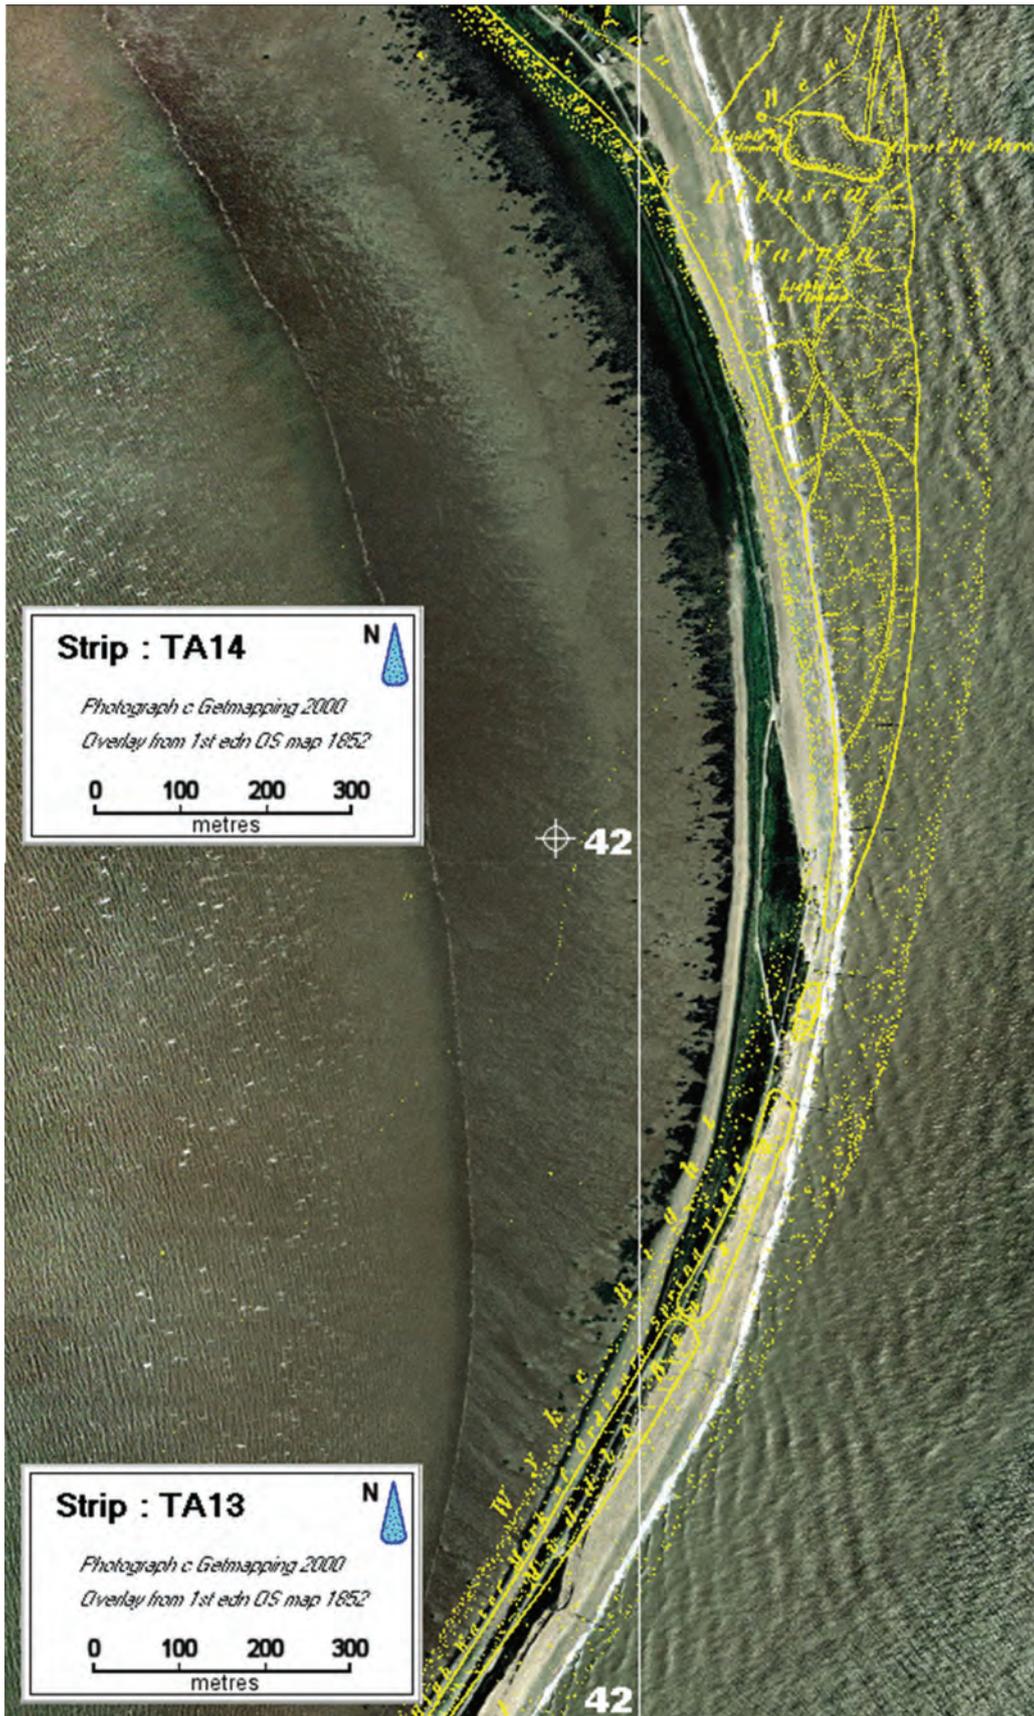
Figure 7 Aerial photograph of the neck of Spurn Peninsula, taken c. 2000, overlain with the first edition County Series Ordnance Survey map surveyed in 1852 (shown in yellow). Source: University of Hull Geography Department of Geography website (www.hull.ac.uk/erosion/index.htm).

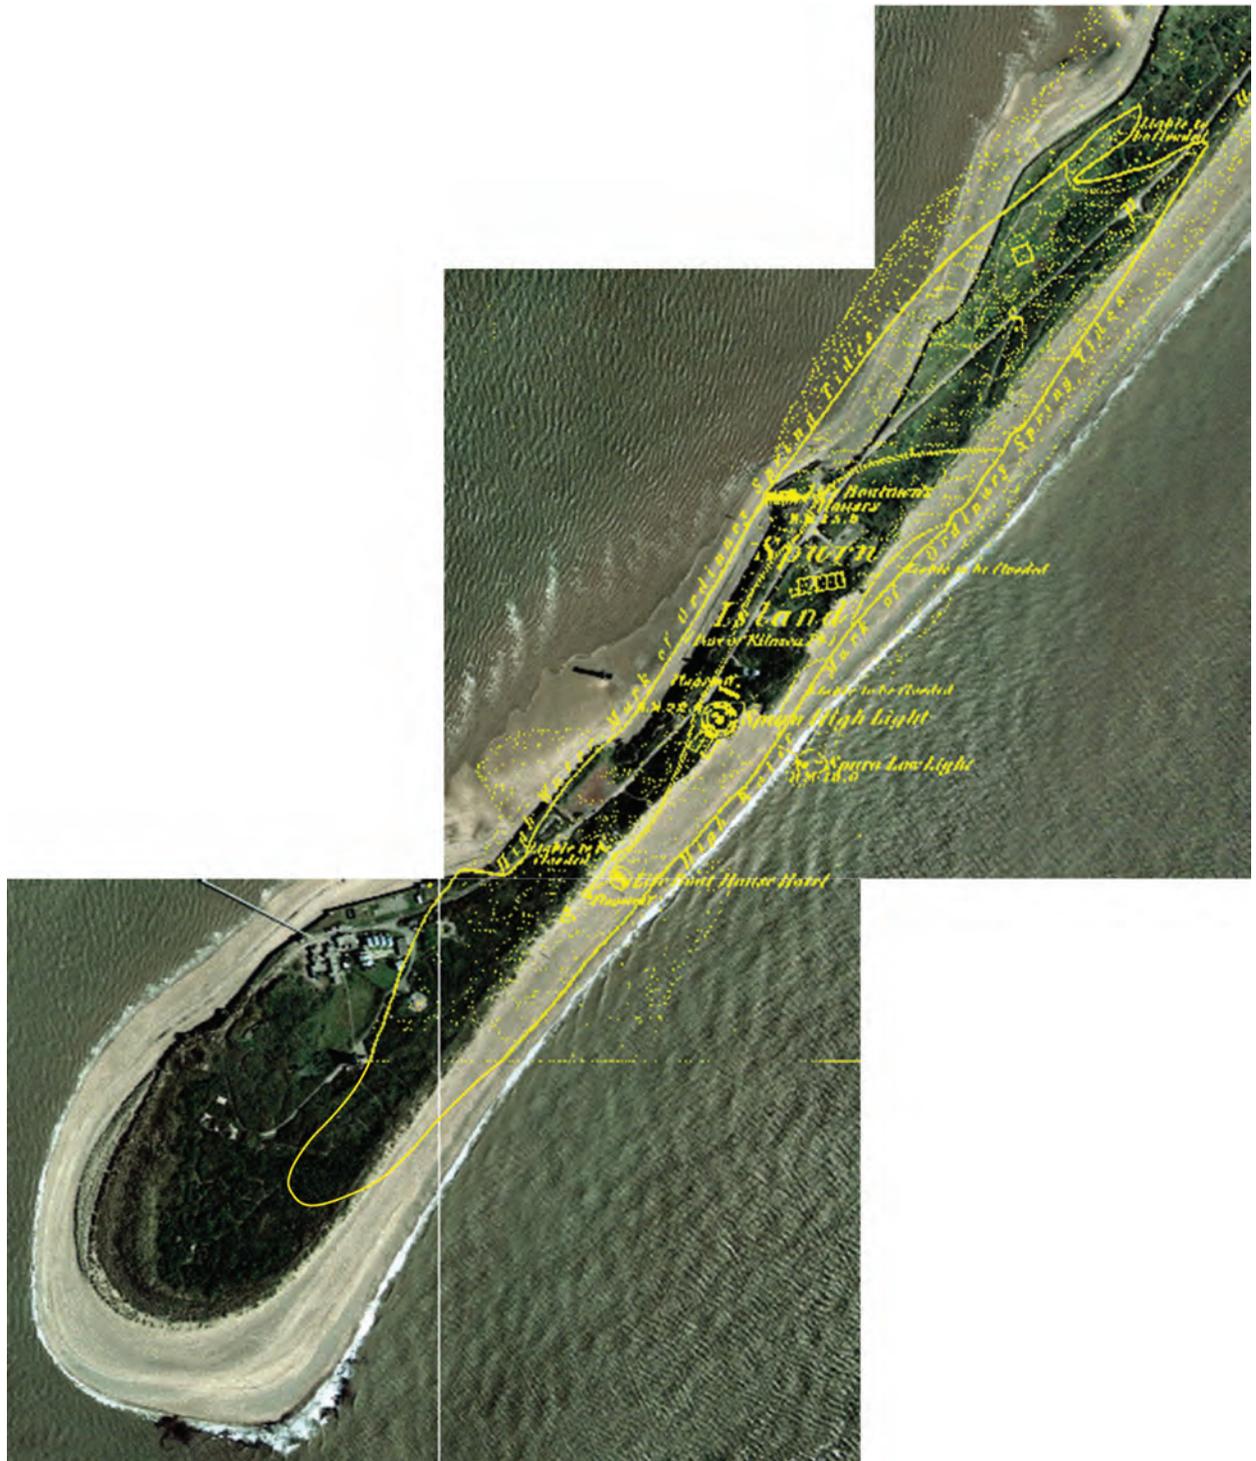
Figure 8 Aerial photograph of Spurn Head, taken c. 2000, overlain with the first edition County Series Ordnance Survey map surveyed in 1852 (shown in yellow). Source: University of Hull Geography Department of Geography website (www.hull.ac.uk/erosion/index.htm).

Sand which is moved southwards along the Binks towards Spurn Head, and which is brought into the Humber estuary by tidal currents, is transported northwards up the western shore of Spurn Head, mainly by refracted waves from the southeast (Phillips, 1963, 1964; Ciavola, 1997). Sand from the upper beach on the south-western side of the Head is transported by south-westerly winds to form dunes, and this process has contributed significantly to westward growth of the spatulate end of the barrier since 1852 (Figure 8).

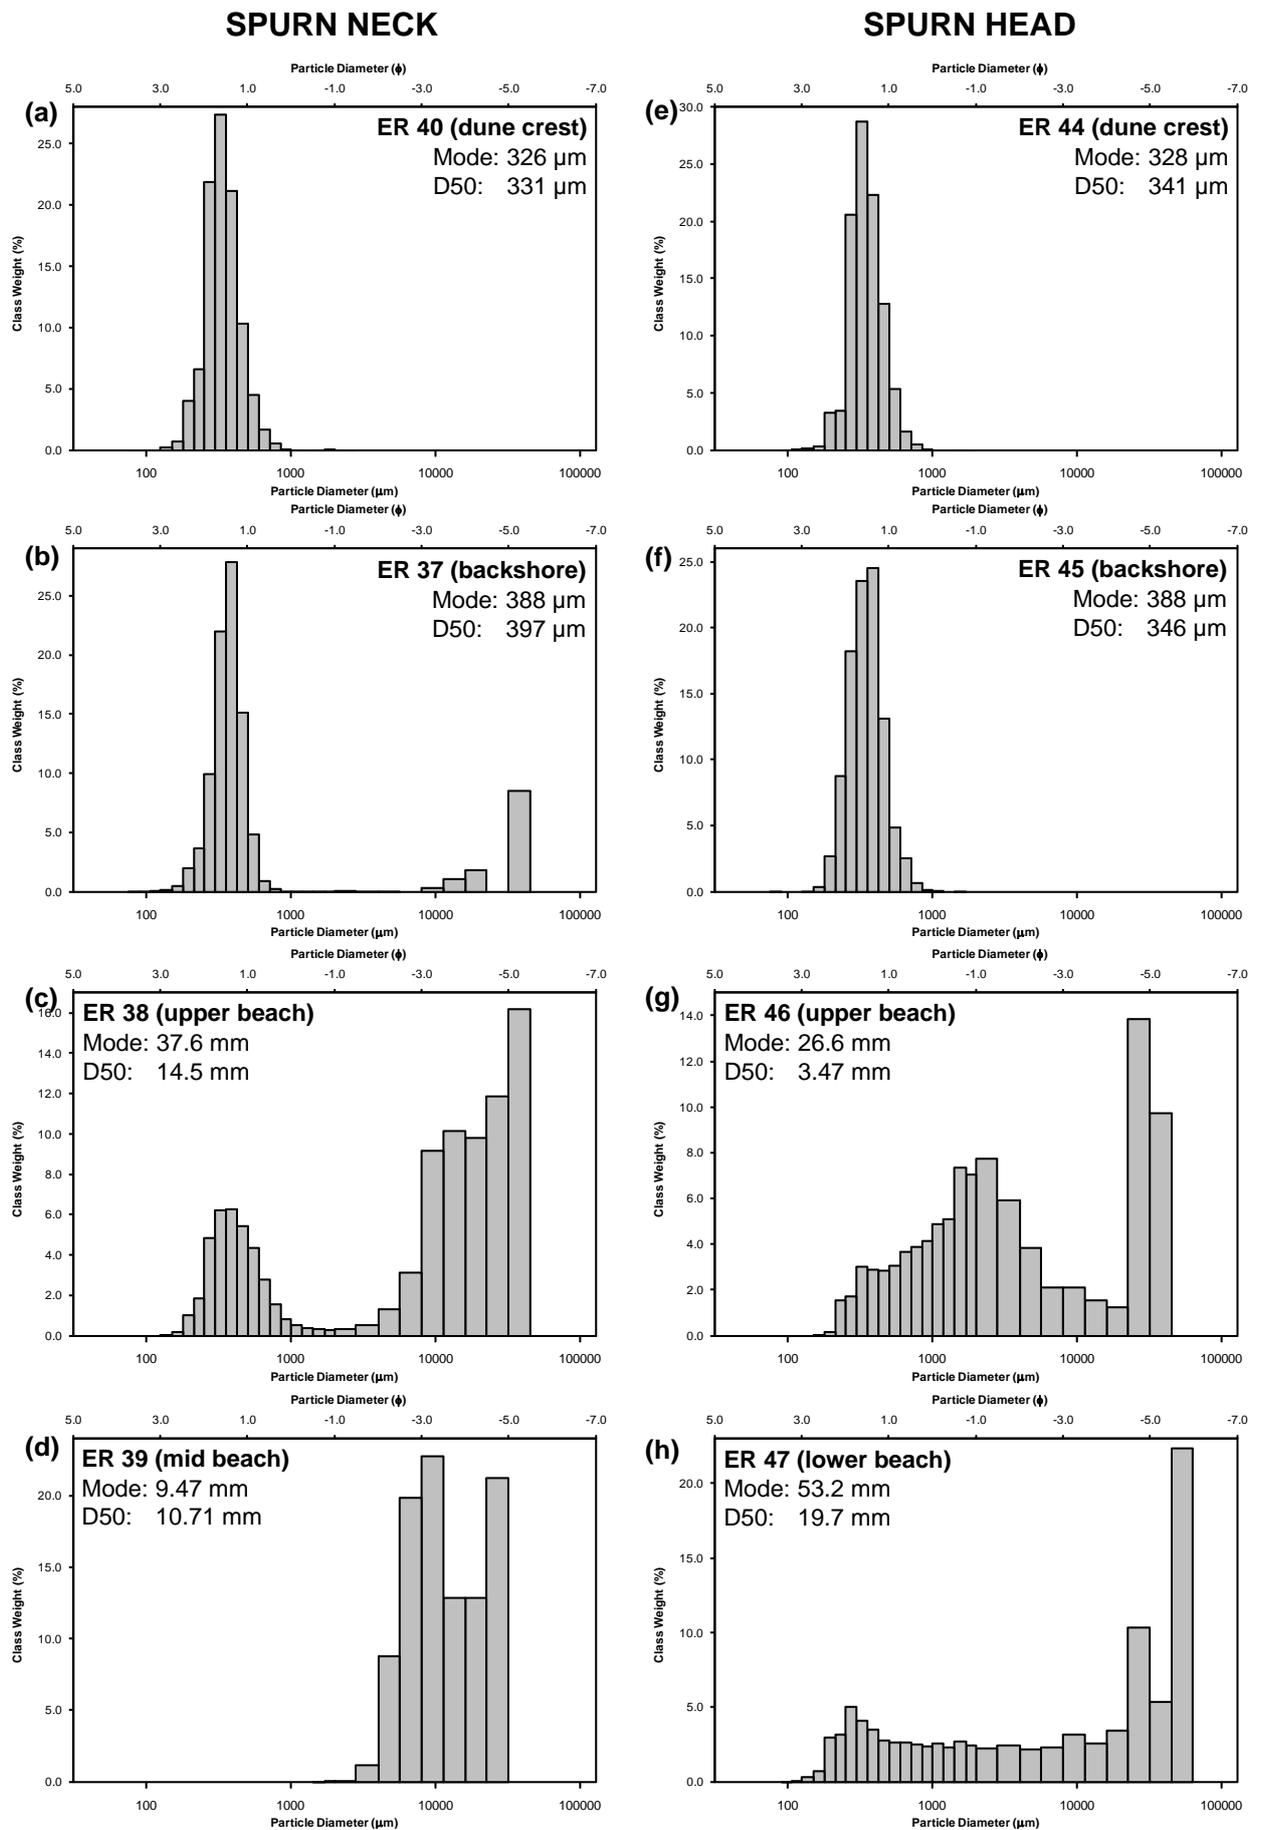
Figure 9 Particle size histograms for sediment samples collected at four cross-shore positions at two locations on the seaward side of Spurn peninsula: (a to d) Spurn Neck; (e to g) Spurn Head.

The modern beaches of the Spurn Peninsula consist of a mixture of sand and gravel and show a high degree of textural variability, depending on wave and tide conditions. Concentrations of gravel and sandy gravel often occur on the lower beach, but most of the beach area consists of sands with 5 to 20% admixed gravel. Along the neck of the barrier significant gravel accumulations are also often found on the backshore and across the full width of the foreshore. The dominant modal size of the sand fraction on the beach and in the dunes lies in the range 325 - 390 μm (Figure 9). The modal sand size of sand on the western side of Spurn Head is slightly finer (250 - 300 μm).

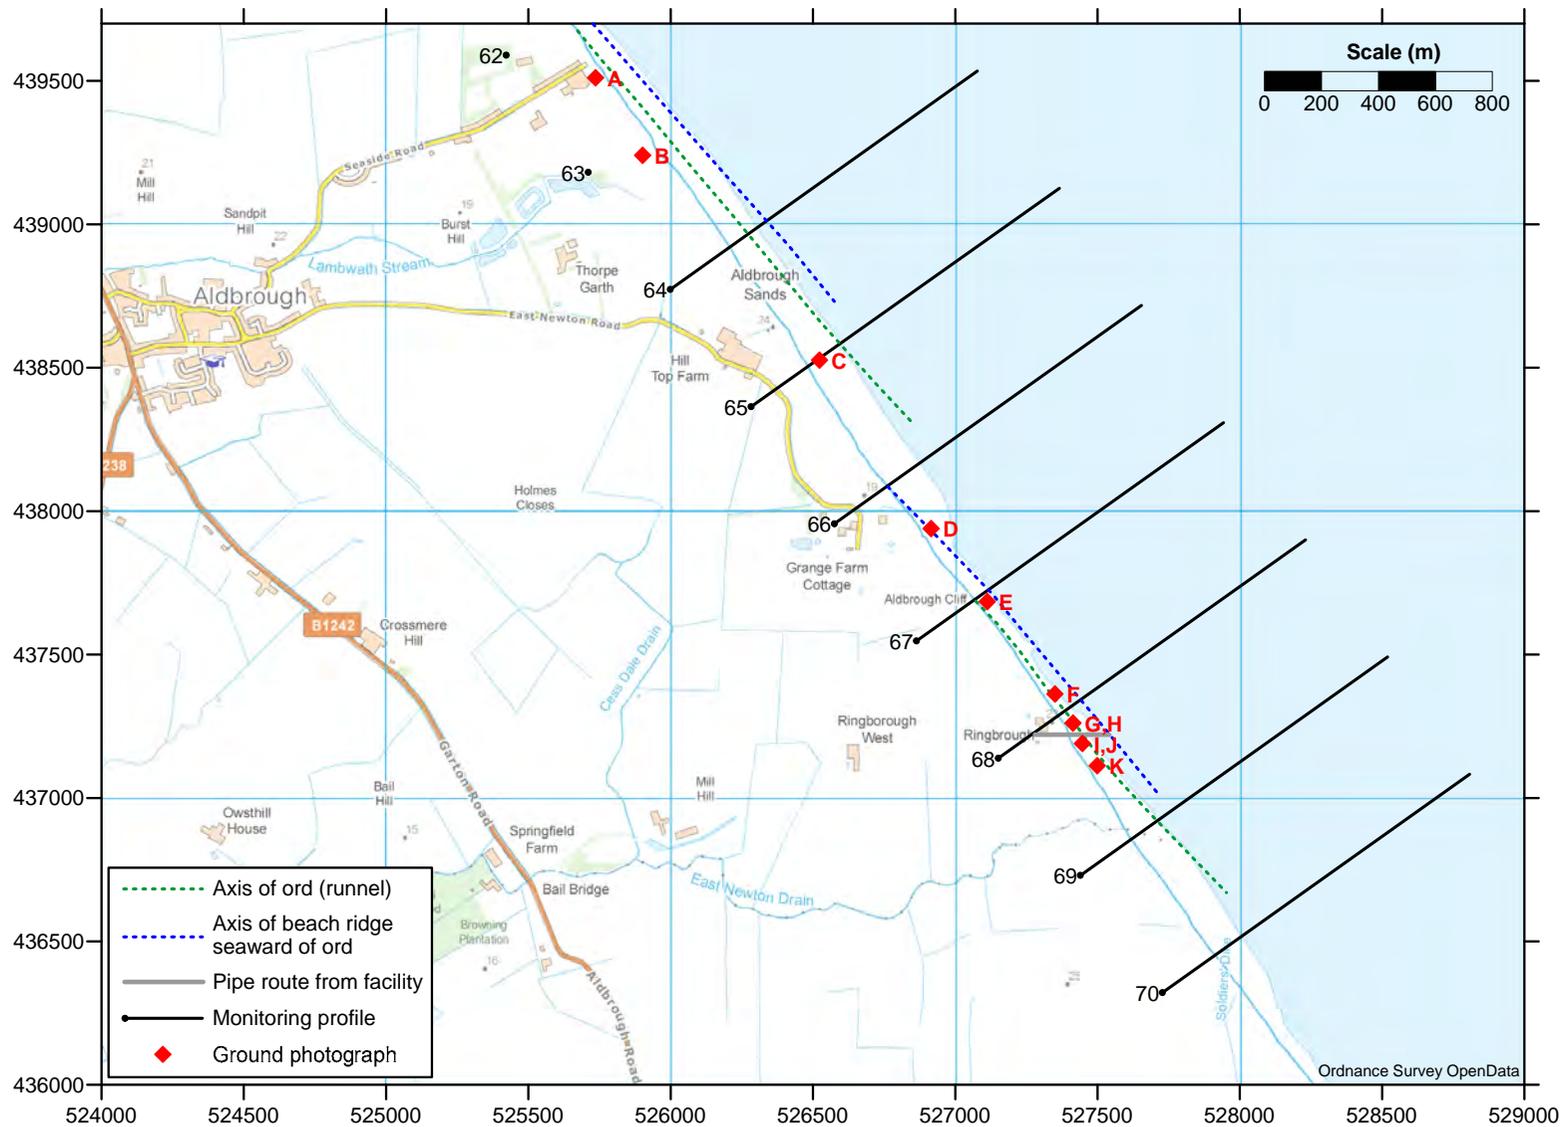
Figure 10 Location map of the study area, with a schematic representation of the position of the ords (runnels) and beach ridges to seaward, mapped in the field during September 2010. Also indicated are the positions of the pipe from the Aldbrough Gas Storage Facility, the position of beach monitoring profiles, and the position of ground photographs.

The Aldbrough Gas Storage Facility pipelines cross the present cliff-line at national grid reference TA 274372, just south of Ringbrough Farm, approximately 3 km south of

Seaside Road, Aldbrough (Figure 10). The site lies on a small hill in the till, and the cliffs in this area achieve a maximum height of about 22 m. Comparison with the First Edition Six Inch Ordnance Survey map and aerial photographs suggests that the cliff top in this area has receded by approximately 230 m since 1852 (Figure 11), 40 m since about 2000 (Figure 12), and 20 m since May 2007 (Figure 13). Erosion monitoring data compiled by ERYC indicate recession at monitoring profile 68, closest to the site, of c.90m since 1951. As on other parts of the Holderness coast, erosion at Ringbrough has been episodic, with periods of relative stability between 1951 and 1966 and between 1984 and 1999, and periods of more rapid erosion between 1967 and 1983, and after 1999. There was a shorter period of stability between 2001 and 2004, followed by significant recession in 2005, and a return to slightly slower recession until September 2008, after which time there was further period of rapid retreat (Figure 14). Owing to this short-term temporal variability, forecasts of future potential sediment yield due to cliff erosion should be based on a period of several years; the period 2003-09 has been used in this report.

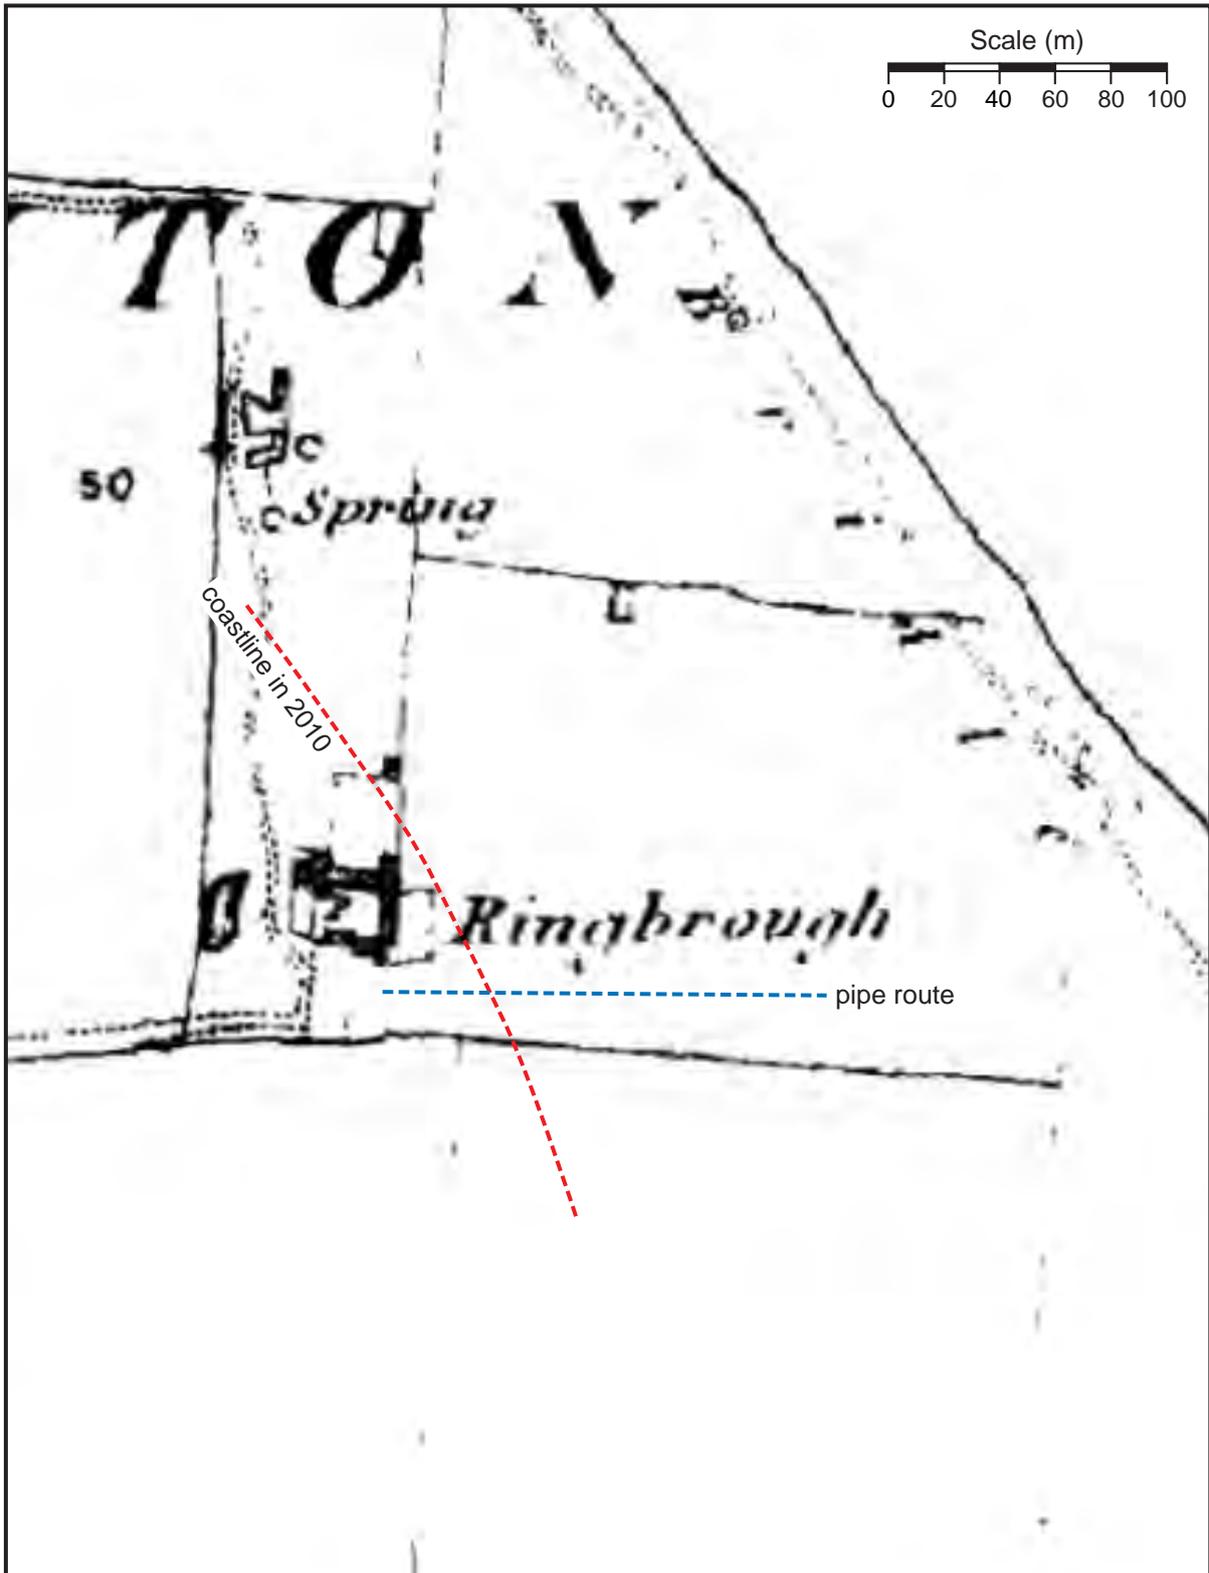
Figure 11 Six inch County Series map of the coastline near Ringbrough Farm, surveyed in 1852 . Dashed lines mark the approximate position of the top of the cliff in 2010, and the position of the underground pipe from the Gas Storage Facility.

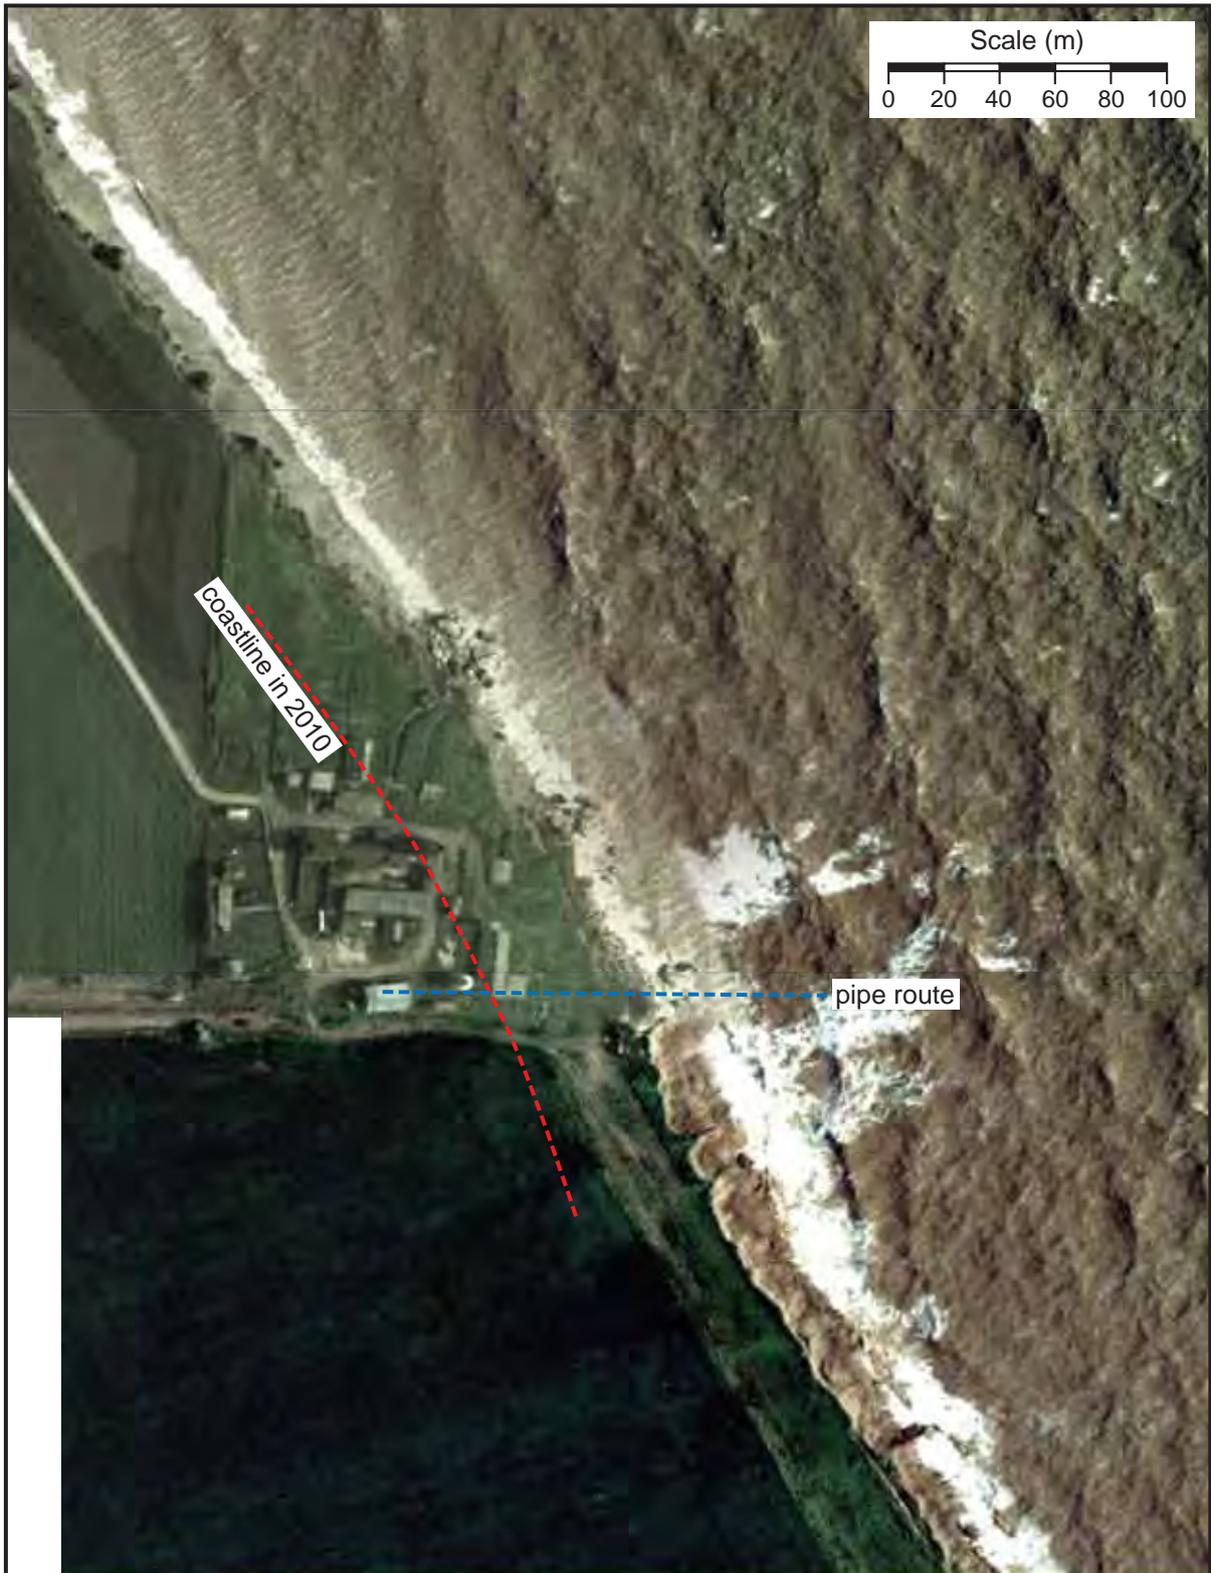
Figure 12 Aerial photographs of the coastline near Ringbrough Farm taken c. 2000. Dashed lines mark the approximate position of the top of the cliff in 2010, and the position of the underground pipe from the Gas Storage Facility. Aerial photograph source: Multimap.

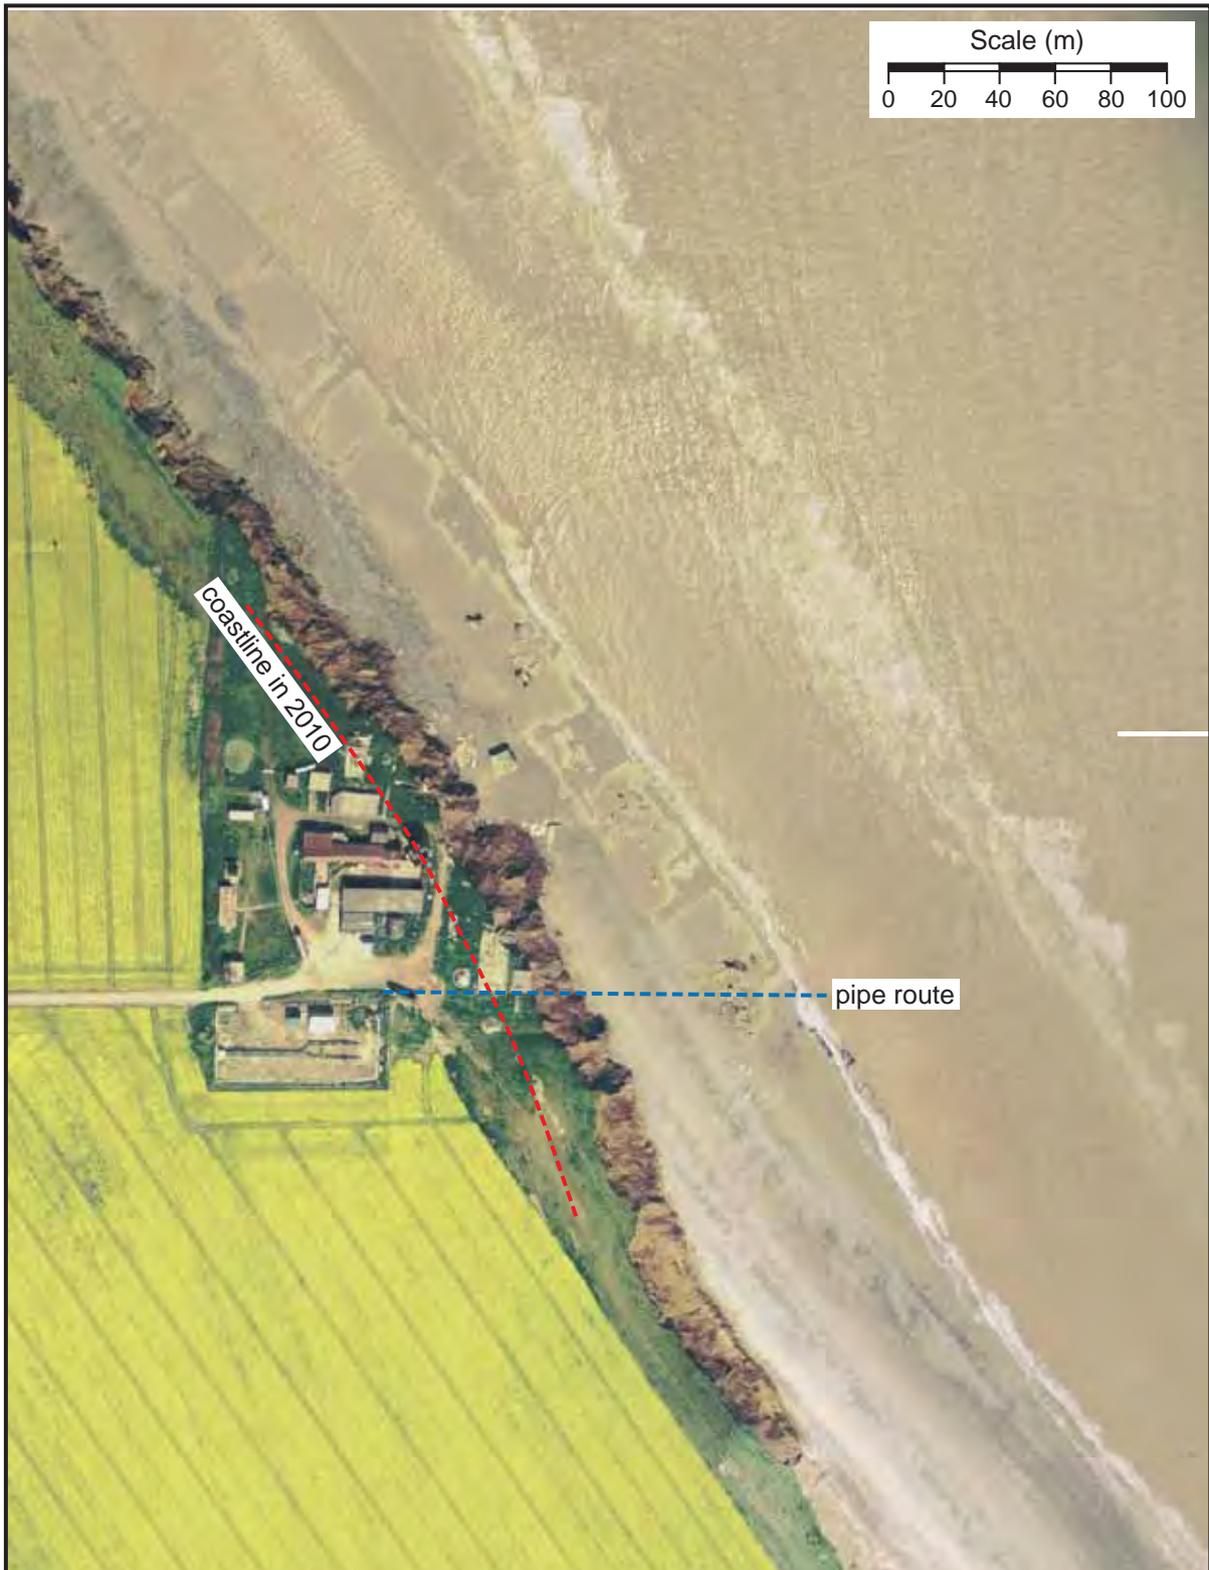
Figure 13 Aerial photographs of the coastline near Ringbrough Farm taken on 7th May 2007. Dashed lines mark the approximate position of the top of the cliff in 2010, and the position of the underground pipe from the Gas Storage Facility. Aerial photograph source: Google Earth.

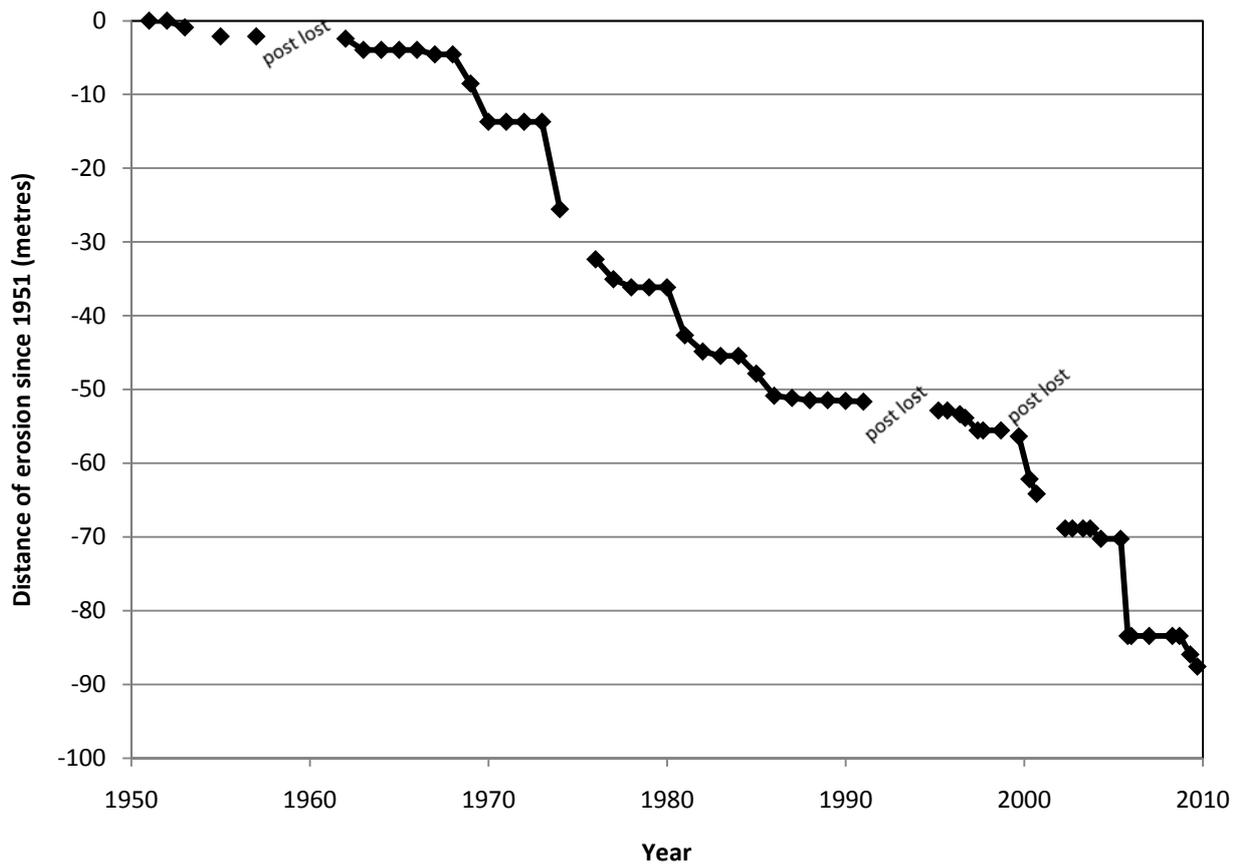
Figure 14 Distances of cliff erosion at Ringbrough Farm (present profile number 68, previous profile number 64), from annual surveys (1951 to 1993) and six-monthly surveys (June 1993 to September 2009). Note that the distances of erosion are unknown between 1957-1961, 1991-1994 and 1997-1998 due to the marker posts being lost. Other breaks in the data indicate periods when no surveying took place.
