Aldbrough Gas Storage Project: Geomorphological assessment of impact of proposed cliff protection works on adjoining areas

External Investigation Report No. EX1214

October 2010

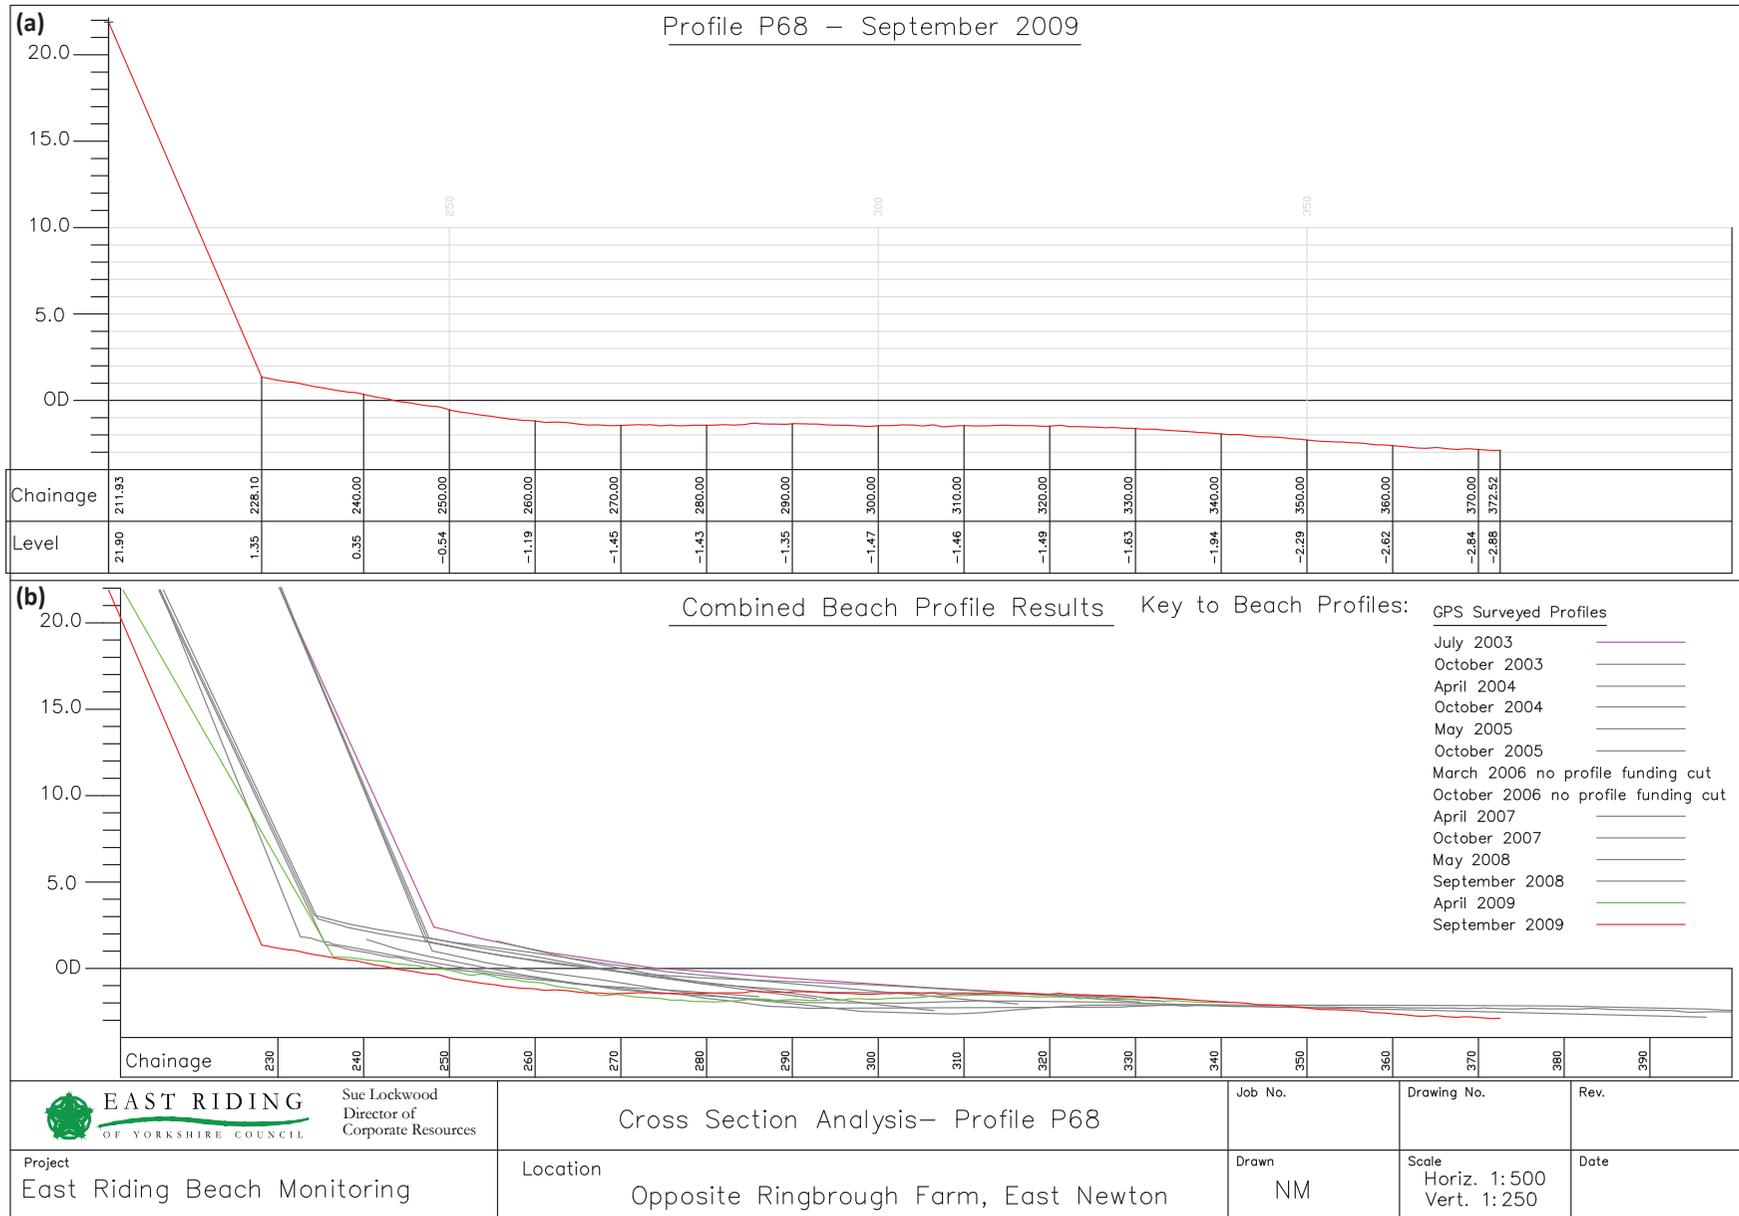
Figure 15 Beach profile 68, at Ringbrough Farm, measured using terrestrial LiDAR by East Riding of Yorkshire Council: (a) the profile measured in September 2009; (b) over of profiles measured July 2003 to September 2009.

Beach profile data obtained by ERYC show that the entire beach profile has moved landwards as the cliffs have receded (Figure 15). In September 2009 the beach consisted of a relatively narrow upper beach slope, a shallow runnel (ord), a mid beach ridge, and a lower beach slope down to the low water mark. Owing to the relatively narrow upper beach, waves are able to reach the cliff toe on almost all tides.

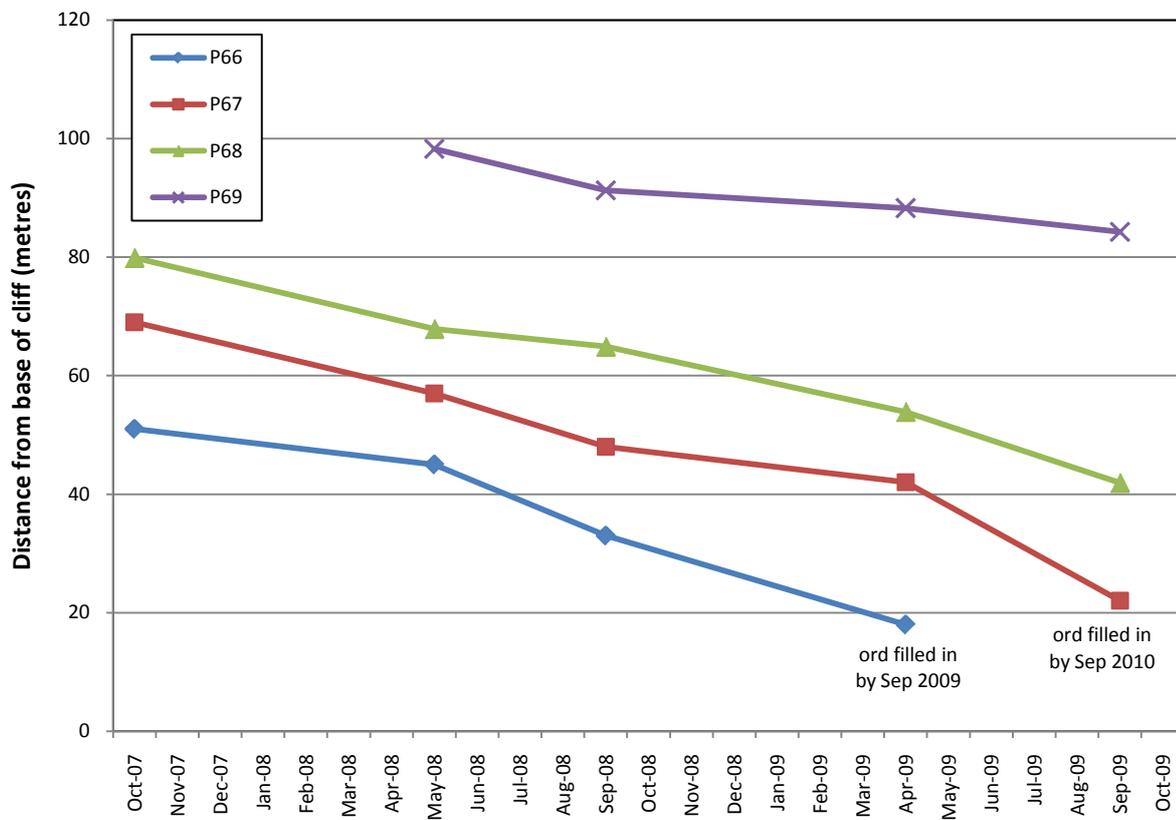
Figure 16 Measurements of the distances of the deepest part of an ord from the toe of the cliff at four profile locations (P66 to P69) near Ringbrough Farm between October 2007 and September 2009.

Analysis of the ERYC beach survey data for profiles P66, P67, P68 and P69 since October 2007 shows that the ord has moved southwards along this frontage at a rate of approximately 500 m per year (Figure 15), which is very similar to the rate of movement reported by Pringle (1985). On this basis, it is likely that within two years the main part of the ord will have moved southwards, beyond Ringbrough Farm, and the northern end of the mid-beach ridge is likely to lie against the cliffs in this area. Without a major increase in storminess, a period of lower cliff recession may be expected after 2012. However, slower recession rates will only be temporary since a further ord, presently centred near Seaside Road, Aldbrough, will also move southwards and affect the Ringbrough Farm frontage after about 2016.

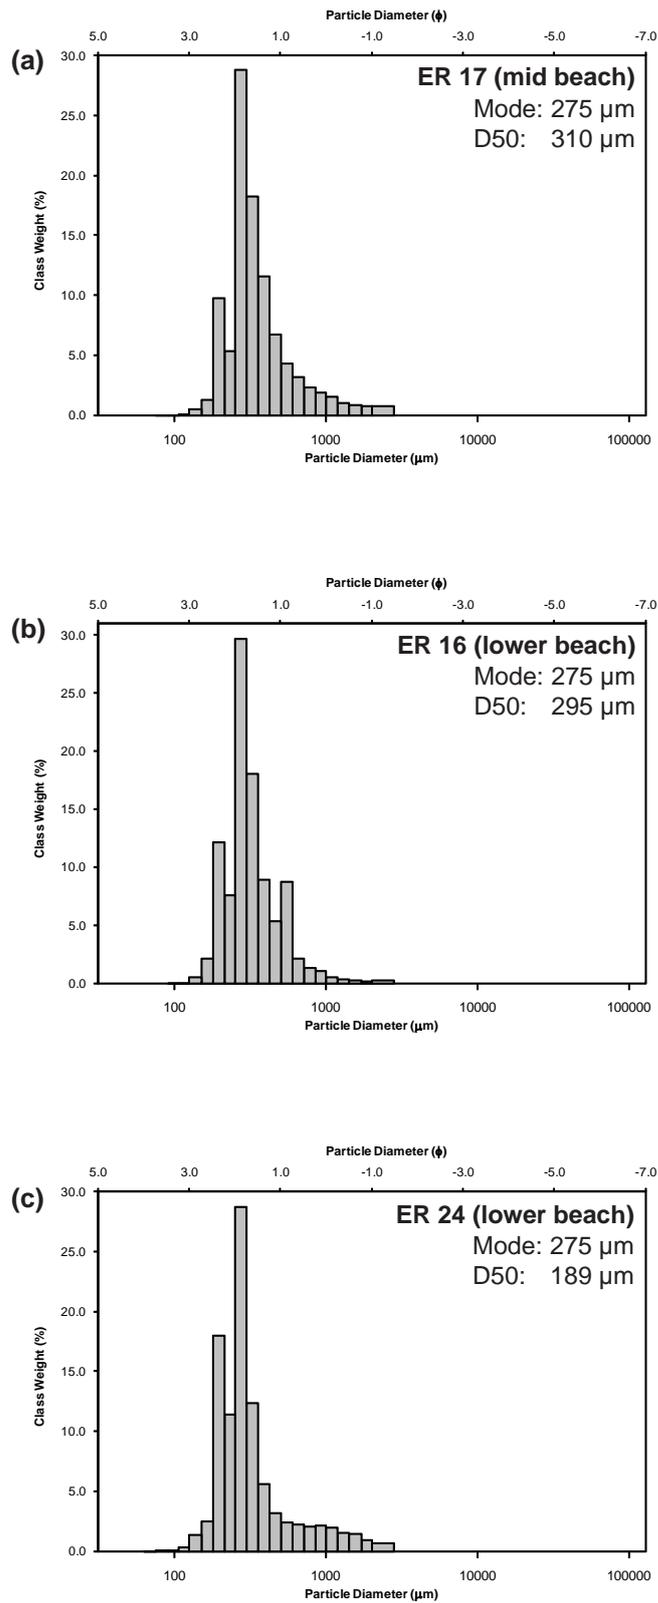
Figure 17 Particle size histograms for sediment samples collected at three cross-shore positions at Aldbrough.

layer (< 0.5 m) overlying the eroded till shore platform. The floor of the trough (ord) to seaward consists of medium sand with some gravel, while the mid-beach ridge is composed mainly of medium sand (Figure 17).

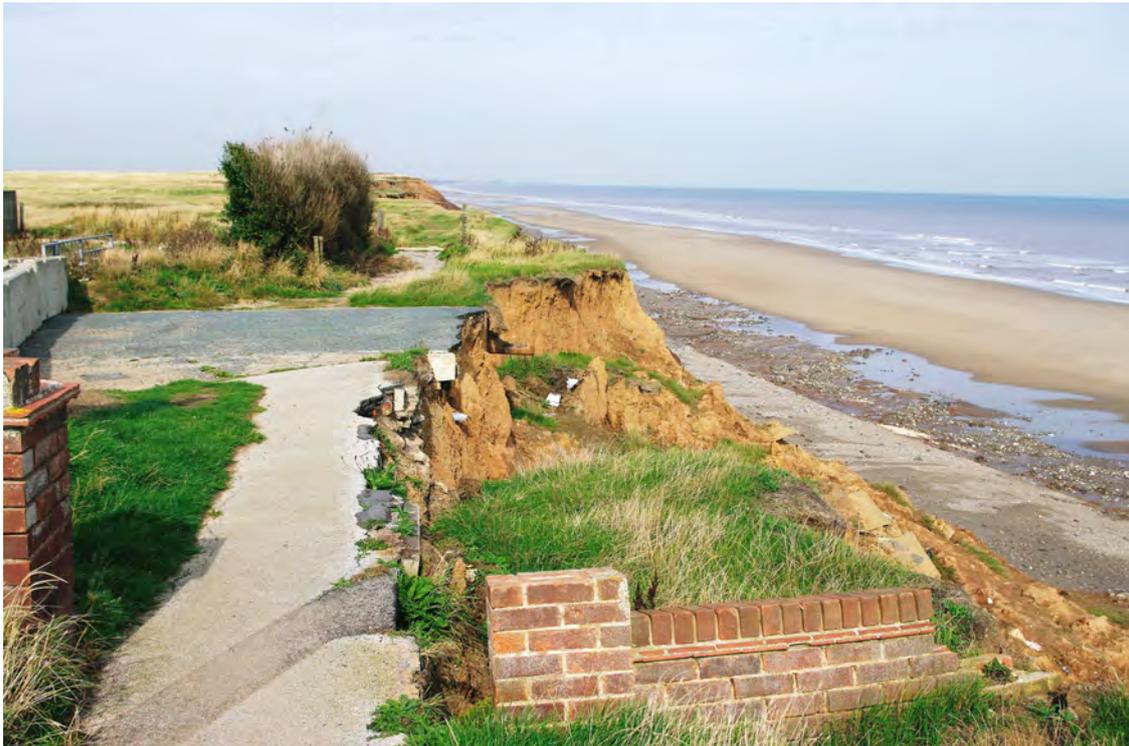
Photo A View northwards at Seaside Road, Aldbrough, showing ord and mid beach ridge close to the cliff toe.

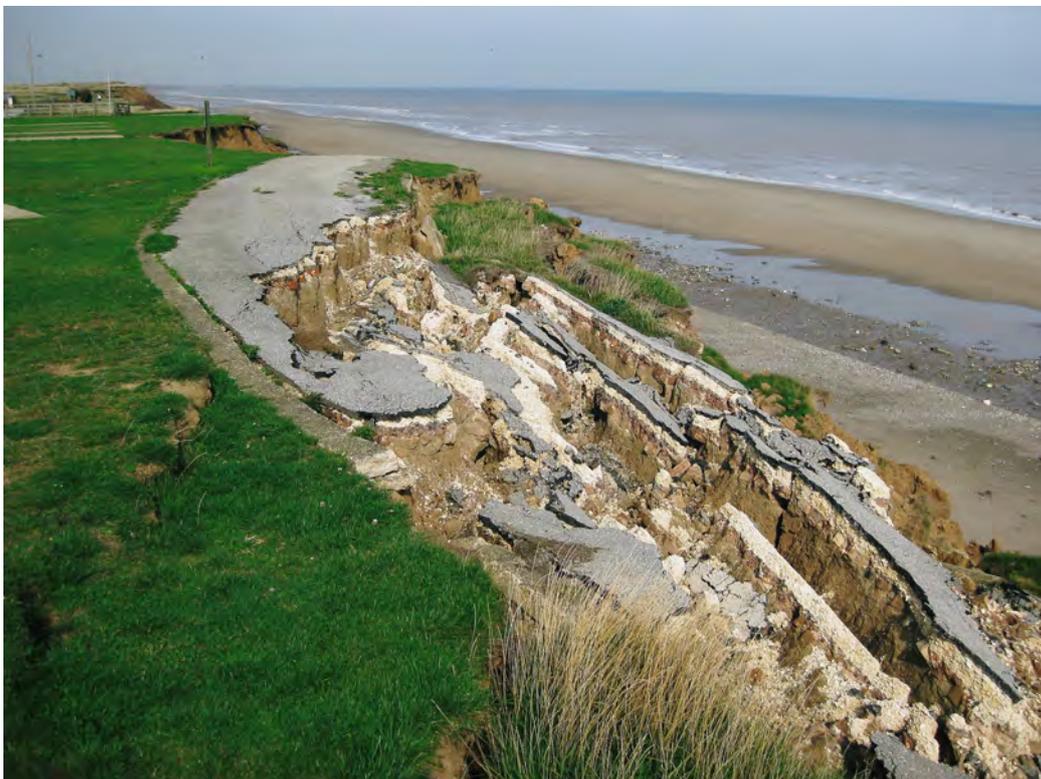
Photo B View northwards from caravan park south of Seaside Road, Aldbrough, showing active cliff movements.

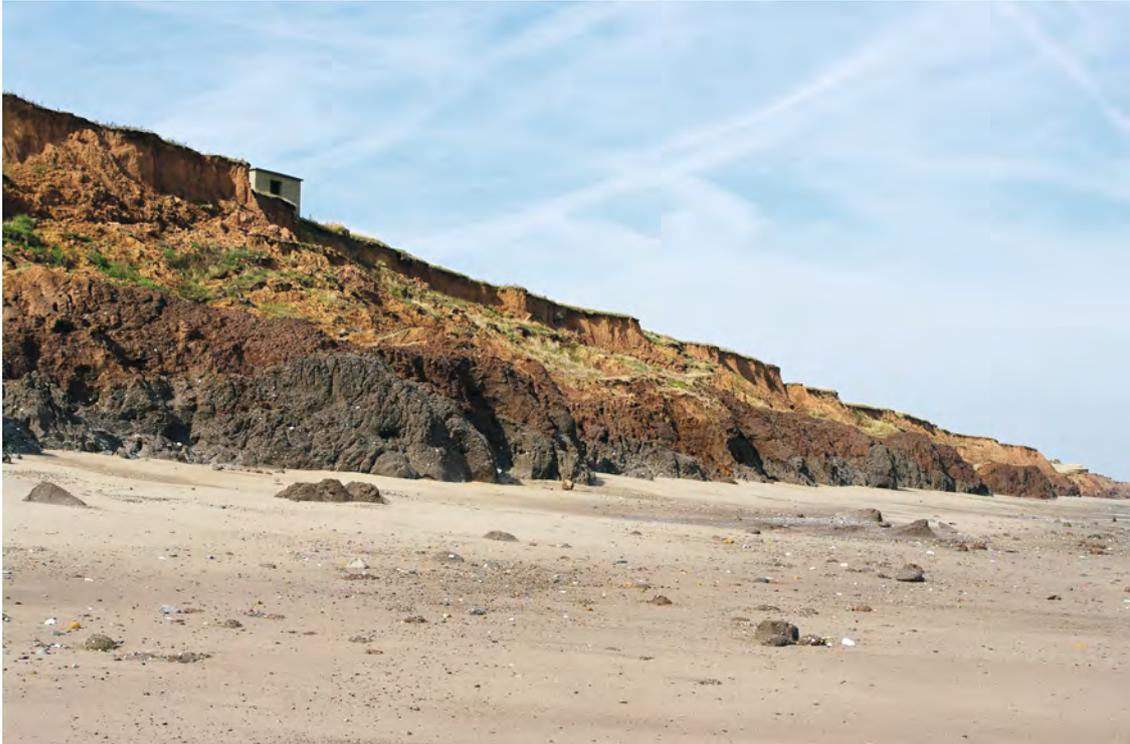
Photo C View northwards from beach near Hill Top Farm, showing high and wide upper beach ramp in front of the cliffs.

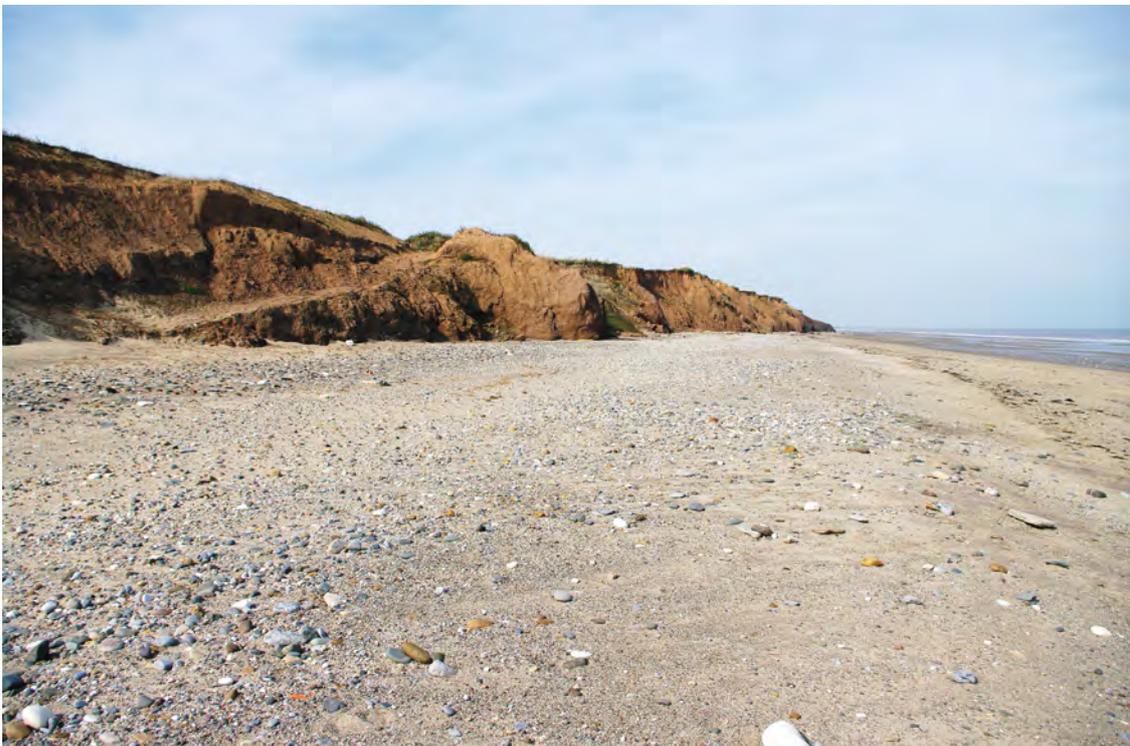
Photo D View northwards from beach near Cliff Farm, showing beach access ramp and wide backshore in front of the till cliffs.

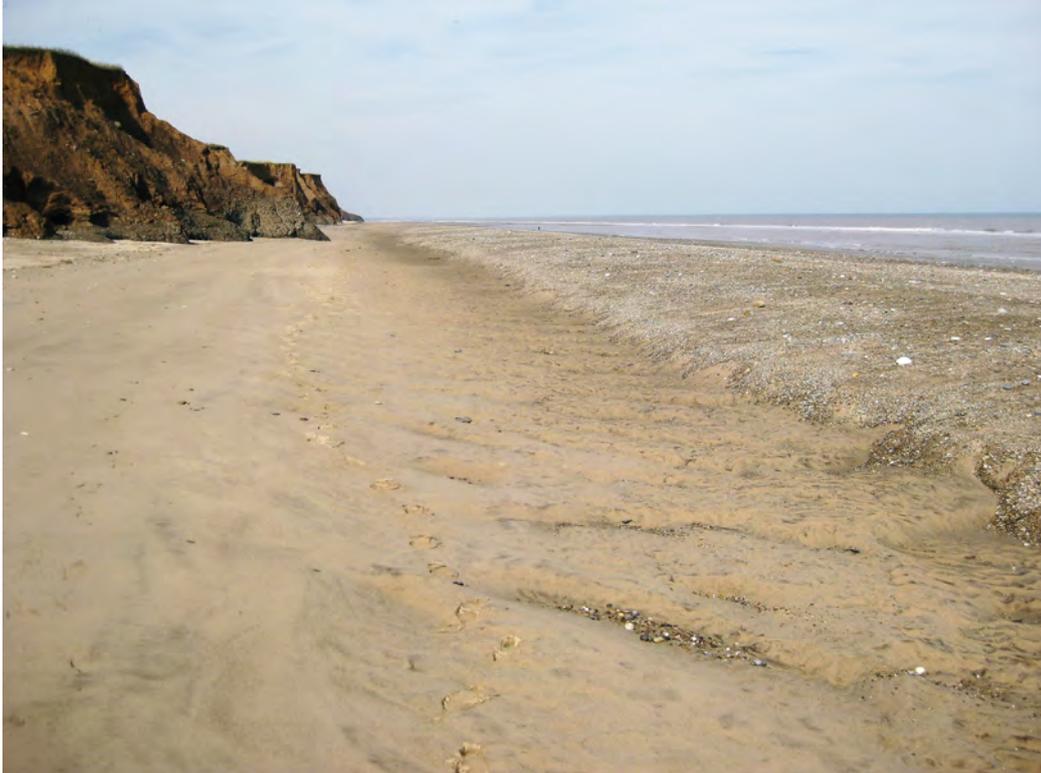
Photo E View northwards, midway between Cliff Farm and Ringbrough Farm, showing northerly limit of the ord which widens and deepens southwards towards Ringbrough.

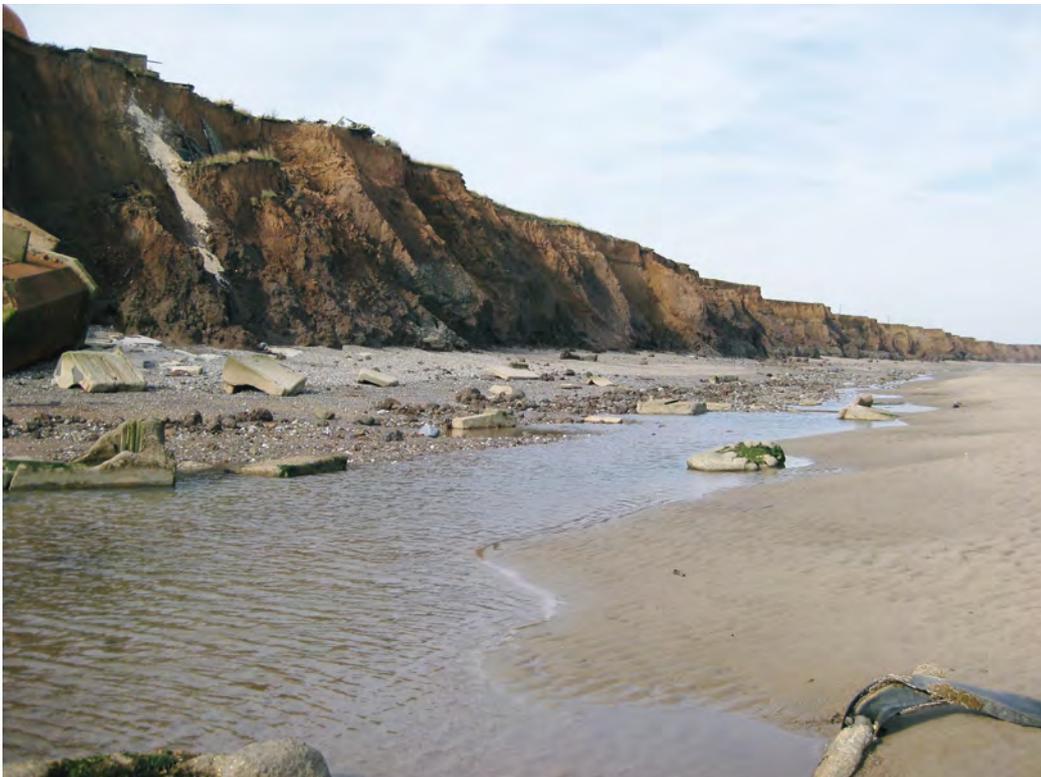
Photo F View northwards from the beach at the northern end of Ringbrough Farm, showing ord close to the cliff toe and concrete debris from collapsed buildings.

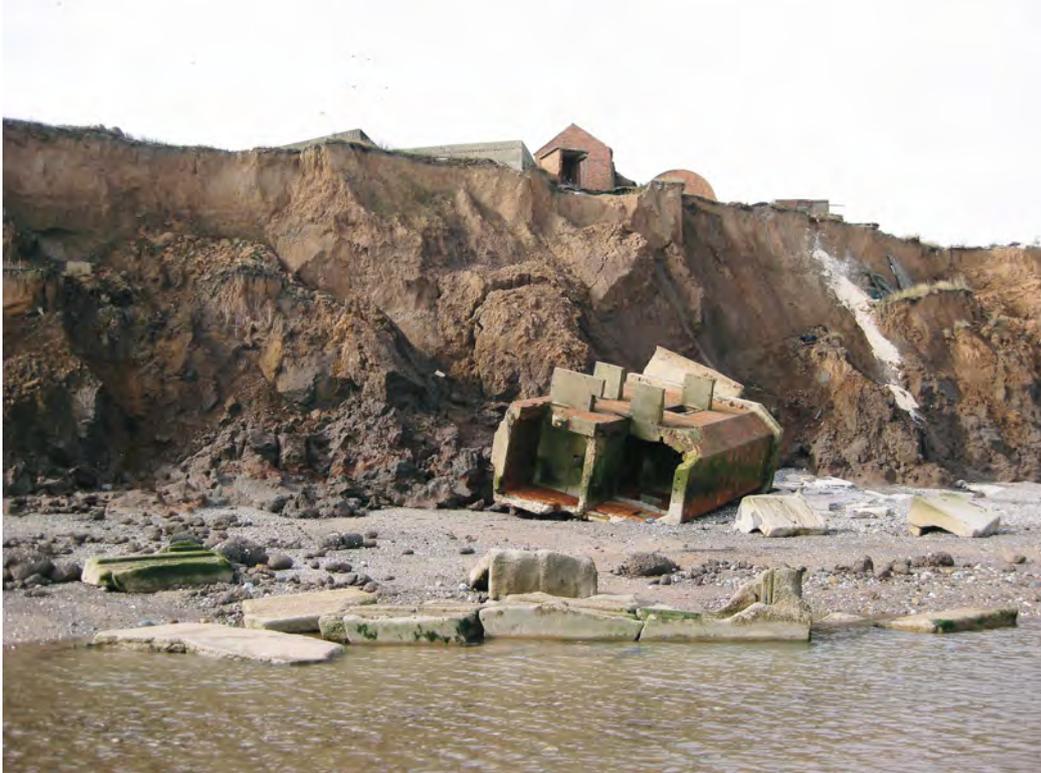
Photo G View landwards from beach opposite Ringbrough Farm, showing water-filled ord close to the cliff toe and collapsed WWII observation tower.

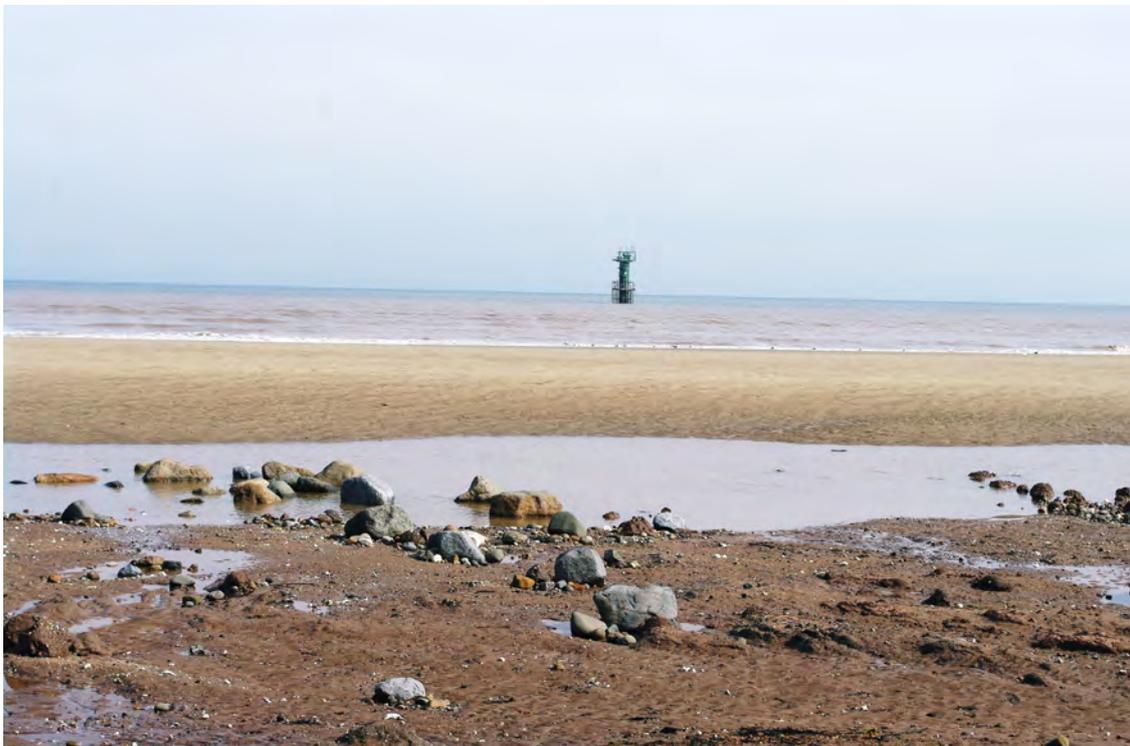
Photo H View seawards from the beach near Ringbrough Farm, showing the water intake tower opposite the pipeline.

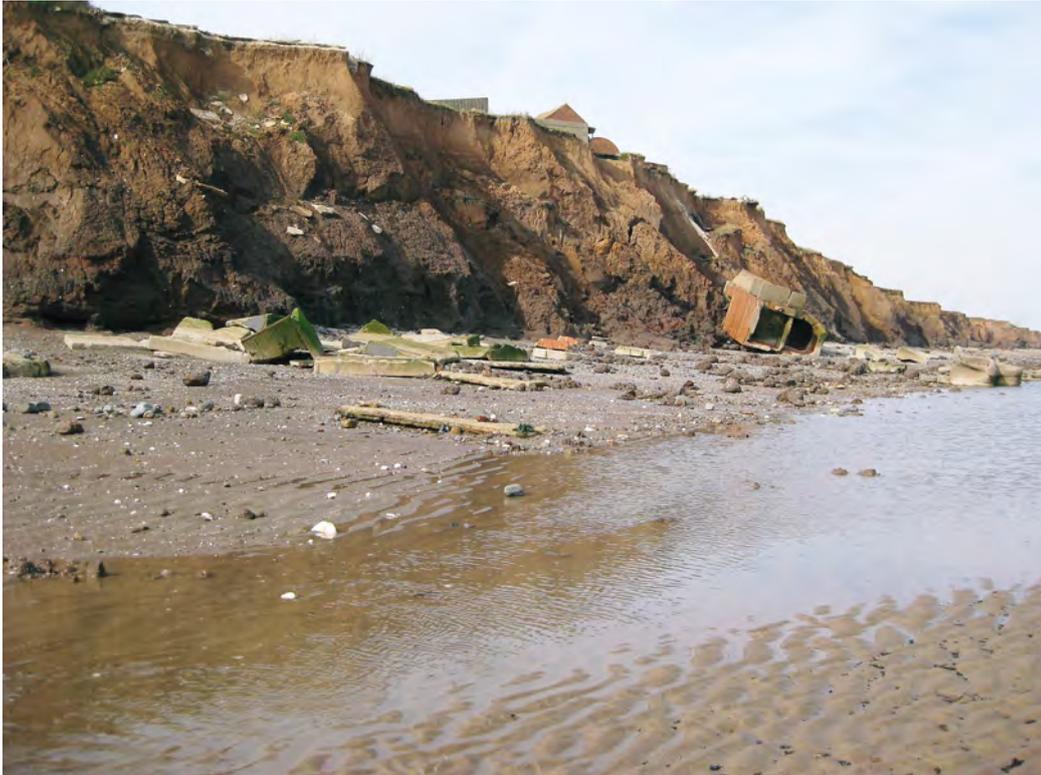
Photo I View northwards from the beach just south of Ringbrough Farm, showing water-filled ord close to the cliff toe.

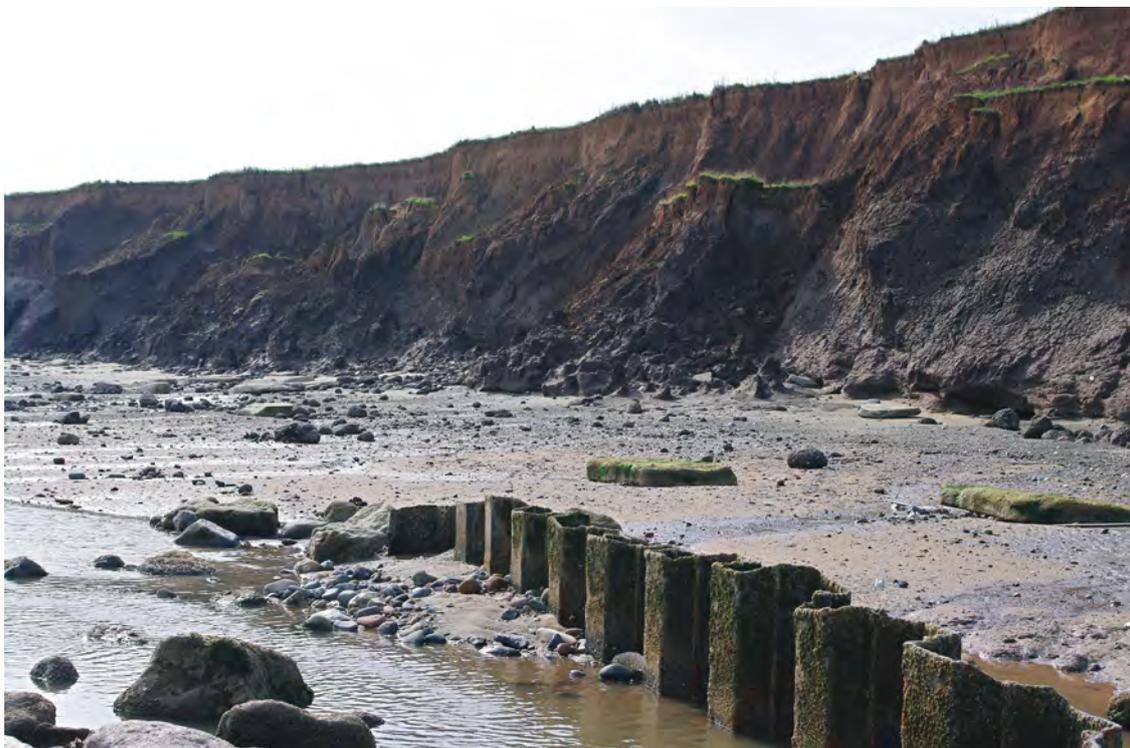
Photo J View southwards from the beach just south of Ringbrough Farm, showing exposed till shore platform.

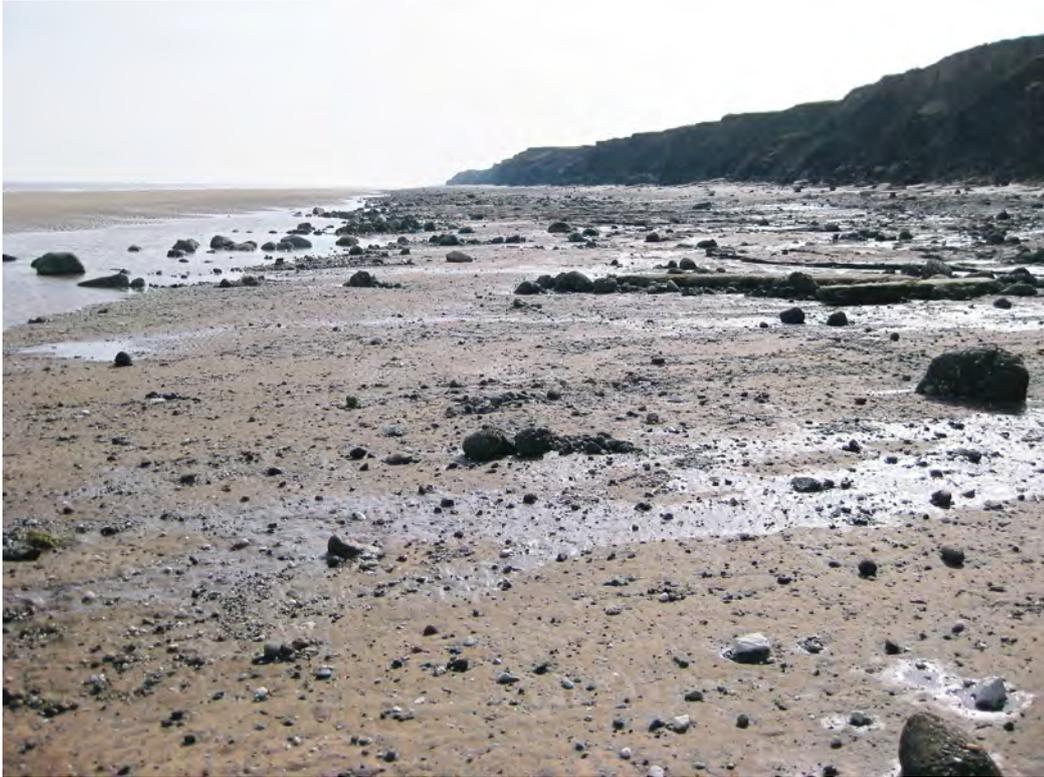
Photo K View southwards from the beach just south of Ringbrough Farm, showing ord diverging seawards from the cliffline.
